Balmeanach Wind Farm

Abnormal Indivisible Load Route Survey

May 2023

107731

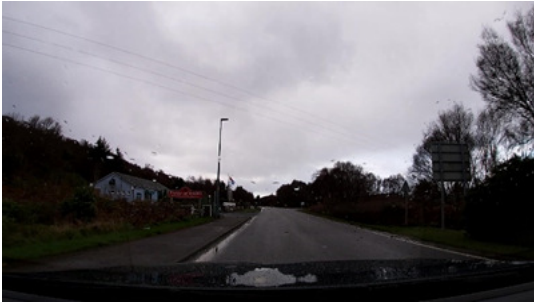
POI	Key Constraint	Details
4	<p>A87 Old Kyle Farm</p>

<p>Loads will continue on the A87 westbound.</p> <p>The blades could be lowered under the overhead cables at this location. Alternatively, to help reduce transit times the cables could be placed under the road.</p>
5	<p>A87 Broadford Airport</p>  	<p>Blade and tower loads will turn right into the Skye Aerodrome and, following storage, will turn right in the direction of the site access.</p> <p>Blades @ 60 Degree and Tower – Inbound</p> <p>A swept path assessment has been undertaken and indicates that the blade tip will over-sail the safety barrier and bollards on the south-eastern verge of the A87.</p> <p>Loads will over-run and over-sail the inside verge of the turn where a load bearing surface should be laid, and the bollards should be removed. The vegetation should be cleared. Third party land will be required.</p> <p>When at the Airport, loads will be discharged, and a temporary crane pad will be required along with a storage area and welfare facility. The developer would be responsible for securing the necessary land option at the airport.</p> <p>Superwing Carrier Blade and Clamp Tower - Outbound</p> <p>A swept path assessment has been undertaken and indicates that the blade tip will over-sail the north-eastern verge of the airport road. Third party land will be required.</p> <p>Loads will over-run and over-sail the inside verge of the turn where a load bearing surface should be laid, and one utility pole, one road sign, two poles, and several bollards should be removed. The vegetation should be cleared. Third party land will be required.</p> <p>Swept path assessment SK03 is included in Appendix B.</p>

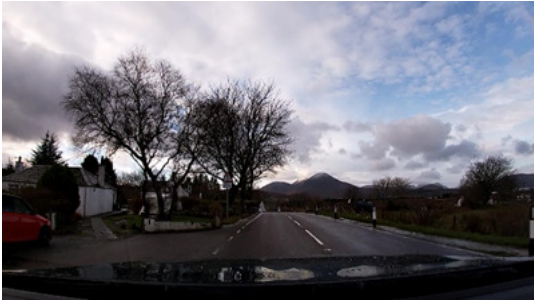
POI	Key Constraint	Details
7	A87 northeast of Ostaig

<p>Loads will continue on the A87 westbound</p> <p>A topographical survey is required to allow for a vertical assessment of this pinch point.</p>
8	A87 Ostaig

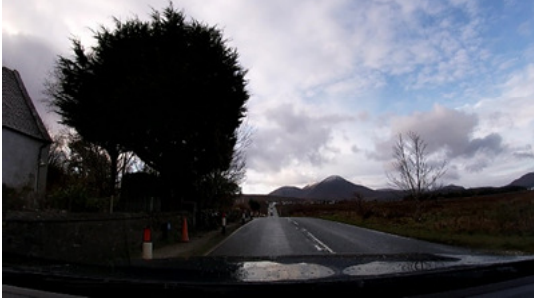
<p>Loads will continue on the A87 westbound.</p> <p>A topographical survey is required to allow for a vertical assessment of this pinch point.</p>
9 & 10	A87 north of Skulamus

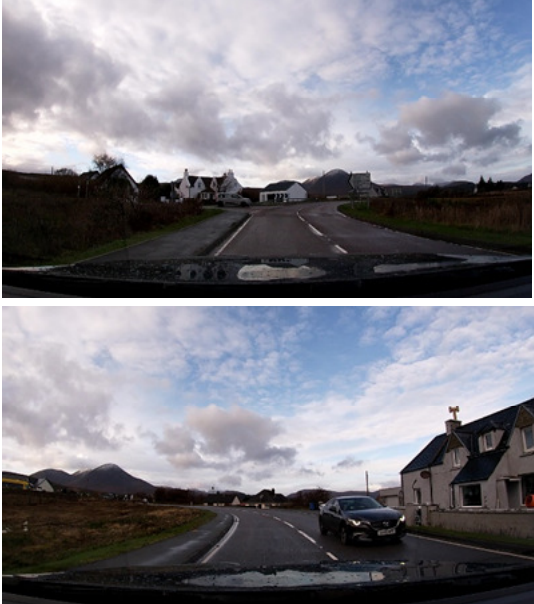
<p>Loads will continue on the A87 westbound.</p> <p>A swept path assessment has been undertaken and indicates that the blade tip will over-sail the outside verge of the right-hand bend, though no physical mitigation measures will be required. Loads will over-sail the inside verge where four road signs should be removed.</p> <p>The blade tip will over-sail one bollard on the outside verge of the following left-hand bend. Loads will over-sail the inside verge, though no physical mitigation measures will be required.</p> <p>Swept path assessment SK05 is included in Appendix B.</p>

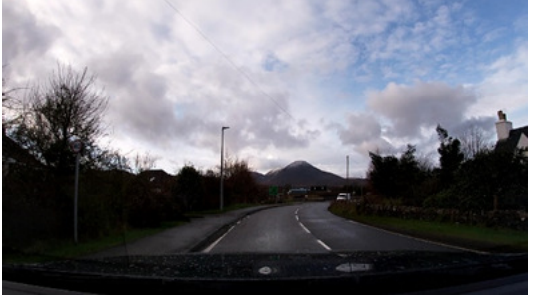
11	A87 Moorlands

<p>Loads will continue on the A87 westbound.</p> <p>A swept path assessment has been undertaken and indicates that loads will over-run and over-sail the outside verge of the right-hand bend where load bearing surfaces should be laid, and two lighting columns, one road sign, and one private sign should be removed. The vegetation should be cleared. Loads will over-sail the inside verge, though no physical mitigation measures will be required.</p> <p>Loads will over-sail both verges through the following left-hand bend, though no physical mitigation measures will be required.</p> <p>Swept path assessment SK06 is included in Appendix B.</p>

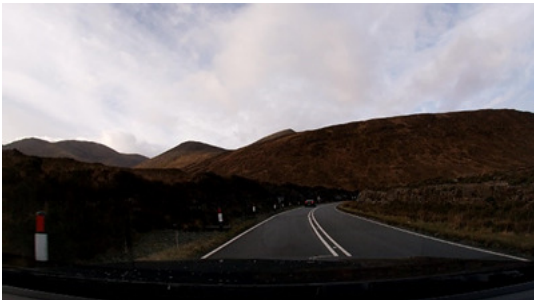
POI	Key Constraint	Details
17	<p>A87 Eas a Bhradain</p>

<p>Loads will continue on the A87 northbound.</p> <p>A swept path assessment has been undertaken and indicates that loads will slightly over-sail the inside verge through the bend, though no physical mitigation measures will be required. The blade tip will over-sail the bollards on the outside verge.</p> <p>Swept path assessment SK10 is included in Appendix B.</p>
18 & 19	<p>A87 Kinloch Ainort</p>

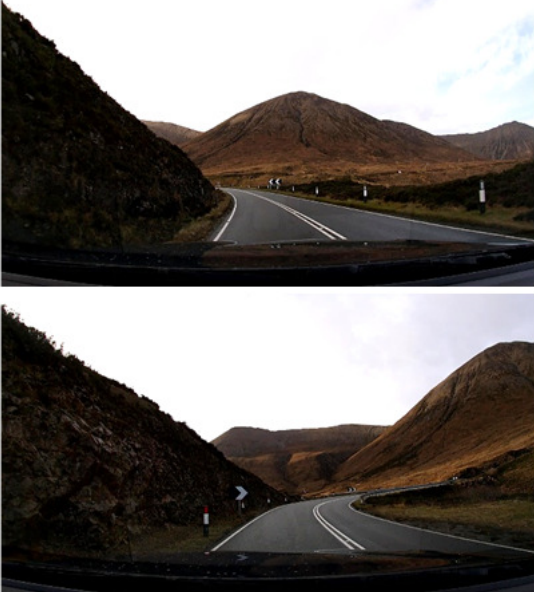
<p>Loads will continue on the A87 northbound.</p> <p>A swept path assessment has been undertaken and indicates that the blade tip will slightly over-sail the outside verge of the left-hand bend, though no physical mitigation measures will be required.</p> <p>Loads will over-sail the inside verge of the following right-hand bend where the rock face should be re-graded, and the safety barrier should be removed. The blade tip will over-sail the bollards and safety barrier on the outside verge where the rock face should be re-graded, and three chevron signs should be removed.</p> <p>To reduce physical works at this location, the use of a scissor lift / shear lift adaptor on the Superwing trailer could be used to raise the blade tip and reduce the extents of any works.</p> <p>Swept path assessment SK11 is included in Appendix B.</p>

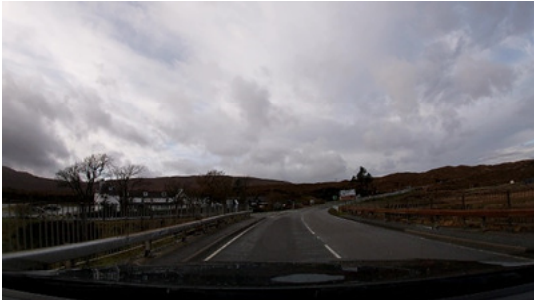
20	<p>A87 / A836 Junction</p>

<p>Loads will continue north on the A87.</p> <p>A swept path assessment has been undertaken and indicates that loads will over-sail the inside verge of the bend, though no physical mitigation measures will be required.</p> <p>Swept path assessment SK25 is included in Appendix B.</p>
43	<p>A87 north of Sligachan</p>

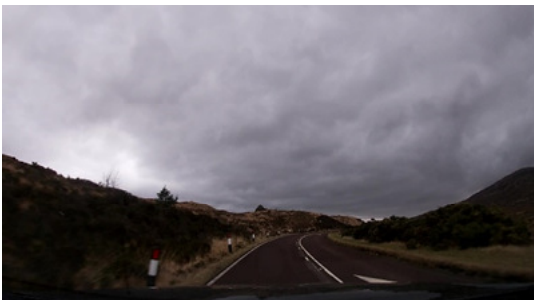
<p>Loads will continue on the A87 northbound.</p> <p>A swept path assessment has been undertaken and indicates that loads will over-sail both verges through the first left-hand bend, though no physical mitigation measures will be required.</p> <p>The blade tip will over-sail the bollards on the outside verge of the following right-hand bend. Loads will over-sail the inside verge where the vegetation should be trimmed, and a land search is recommended to confirm the extent of the adopted land boundary.</p> <p>Swept path assessment SK26 is included in Appendix B.</p>

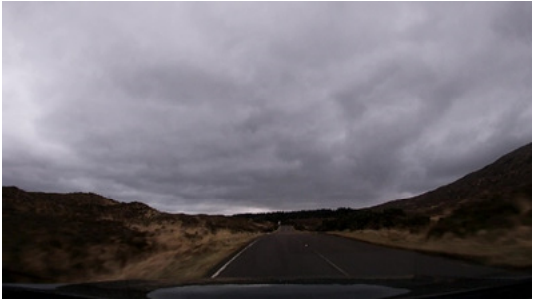
POI	Key Constraint	Details
44	A87 Caiplach

<p>Loads will continue on the A87 northbound.</p> <p>The vertical profile of the road at this location is pronounced and should be reviewed during the test run stage to ascertain if tar wedges will be required to prevent grounding.</p>
45	A87 west of Meall Odhar Mor

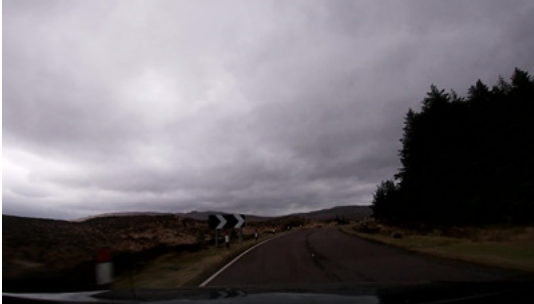
<p>Loads will continue on the A87 northbound.</p> <p>A swept path assessment has been undertaken and indicates that the blade tip will over-sail the bollards on the outside verge of the left-hand bend where four chevron signs should be removed, and the vegetation should be trimmed. Loads will over-sail the inside verge, though no physical mitigation measures will be required.</p> <p>Loads will over-sail the inside verge of the following right-hand bend where the vegetation should be trimmed. The blade tip will over-sail the bollards on the outside verge where two chevron signs should be removed, and a land search is recommended to confirm the extent of the adopted land boundary.</p> <p>Swept path assessment SK27 is included in Appendix B.</p>

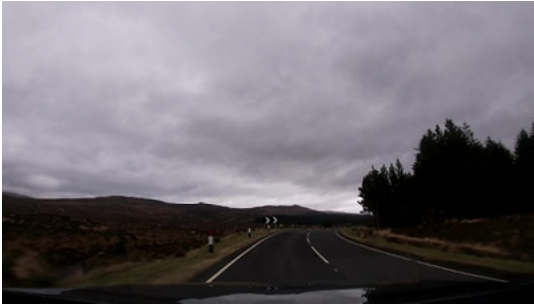
46	A87 east of Doir a Bhuilg

<p>Loads will continue on the A87 northbound.</p> <p>A swept path assessment has been undertaken and indicates that loads will over-sail the eastern verge prior to the bend, though no physical mitigation measures will be required.</p> <p>The blade tip will over-sail the bollards on the outside verge of the bend. Loads will over-sail the inside verge where the trees and vegetation should be trimmed.</p> <p>Swept path assessment SK28 is included in Appendix B.</p>
47	A87 Glen Varragill Forest

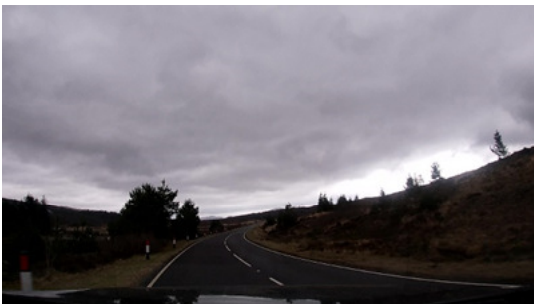
<p>Loads will continue on the A87 northbound.</p> <p>A swept path assessment has been undertaken and indicates that the blade tip will over-sail the bollards on the outside verge of the left-hand bend. Loads will over-sail the inside verge, though no physical mitigation measures will be required.</p> <p>The blade tip will over-sail the bollards on the outside verge of the following right-hand bend. Loads will over-sail the inside verge, though no physical mitigation measures will be required.</p> <p>Swept path assessment SK29 is included in Appendix B.</p>

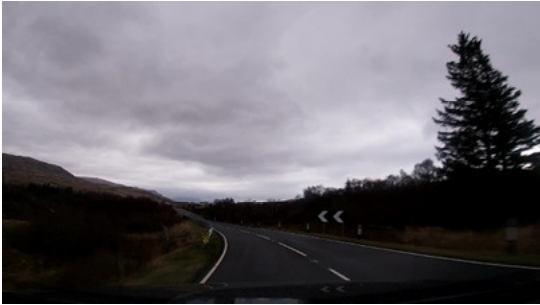
POI	Key Constraint	Details
48	<p>A87 south of Varragill</p>

<p>Loads will continue on the A87 northbound.</p> <p>A swept path assessment has been undertaken and indicates that the blade tip will over-sail the bollards on the outside verge of the right-hand bend where one chevron sign should be removed. Loads will over-sail the inside verge, though no physical mitigation measures will be required.</p> <p>The blade tip will over-sail the bollards on the outside verge of the following left-hand bend where one chevron sign should be removed. Loads will over-sail the safety barrier on the inside verge.</p> <p>Swept path assessment SK30 is included in Appendix B.</p>
49	<p>A87 Varragill</p>

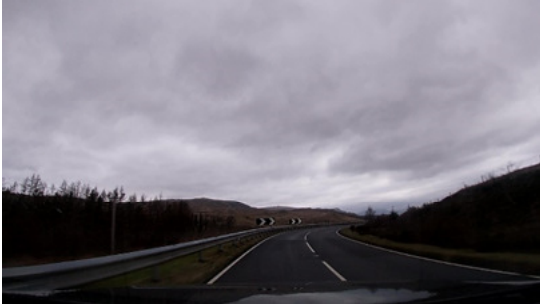
<p>Loads will continue on the A87 northbound.</p> <p>A swept path assessment has been undertaken and indicates that the blade tip will over-sail the safety barrier on the outside verge of the right-hand bend where one chevron sign should be removed. Loads will over-sail the inside verge, though no physical mitigation measures will be required.</p> <p>Loads will over-sail the inside verge of the following left-hand bend where the vegetation should be trimmed.</p> <p>The blade tip will over-sail the bollards on the outside verge of the second right-hand bend. Loads will over-sail the inside verge where the bollards should be removed.</p> <p>Swept path assessment SK31 is included in Appendix B.</p>

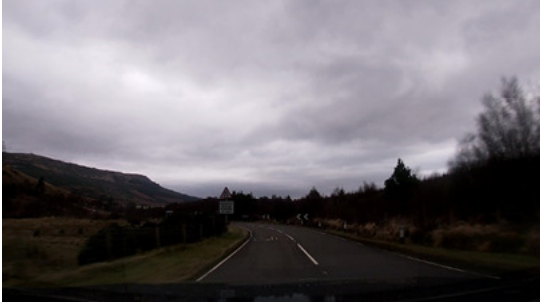
50	<p>A87 east of Ben Gaskin</p>

<p>Loads will continue on the A87 northbound.</p> <p>A swept path assessment has been undertaken and indicates that the blade tip will over-sail the bollards on the outside verge of the left-hand bend where four chevron signs should be removed, and the vegetation should be trimmed. Loads will over-sail the inside verge, though no physical mitigation measures will be required.</p> <p>Swept path assessment SK32 is included in Appendix B.</p>
51	<p>A87 Glenvarragill House</p>

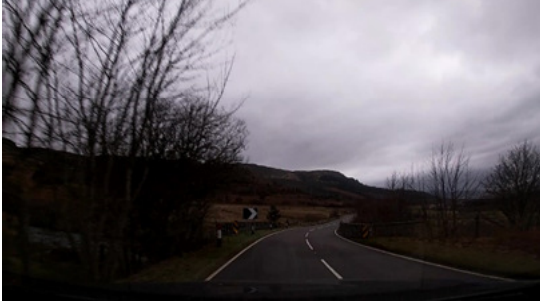
<p>Loads will continue on the A87 northbound.</p> <p>A swept path assessment has been undertaken and indicates that loads will over-sail both verges prior to the bends, though no physical mitigation measures will be required.</p> <p>The blade tip will over-sail the bollards on the outside verge of the left-hand bend. Loads will over-sail the inside verge, though no physical mitigation measures will be required.</p> <p>The blade tip will over-sail the bollards on the outside verge of the following right-hand bend where the trees should be trimmed. Loads will over-sail the inside verge, though no physical mitigation measures will be required.</p> <p>Swept path assessment SK33 is included in Appendix B.</p>

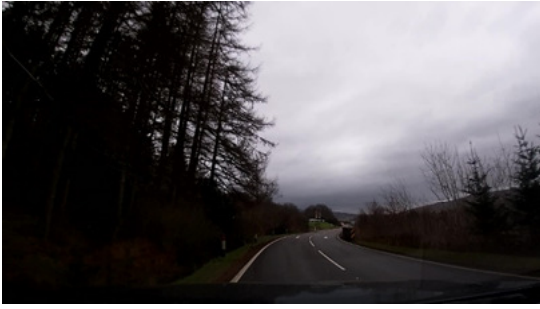
POI	Key Constraint	Details
52	<p>A87 Eilean Chaluim-chille</p>

<p>Loads will continue on the A87 northbound.</p> <p>A swept path assessment has been undertaken and indicates that the blade tip will over-sail the bollards on the outside verge of the left-hand bend. Loads will over-sail the inside verge, though no physical mitigation measures will be required.</p> <p>The blade tip will over-sail the bollards on the outside verge of the following right-hand bend where one road sign should be removed. Loads will over-sail the inside verge, though no physical mitigation measures will be required.</p> <p>Swept path assessment SK34 is included in Appendix B.</p>
53	<p>A87 Shullishadder</p>

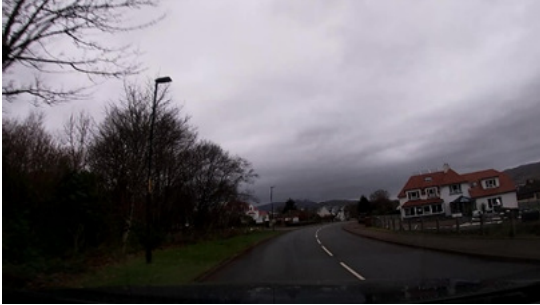
<p>Loads will continue on the A87 northbound.</p> <p>A swept path assessment has been undertaken and indicates that the blade tip will over-sail the outside verge of the bend, though no physical mitigation measures will be required.</p> <p>The tree canopy should be trimmed to ensure that there is a 5m clear head height. Trimming works can be subject to ecological time constraints and early engagement with the relevant authority is recommended.</p> <p>Swept path assessment SK35 is included in Appendix B.</p>

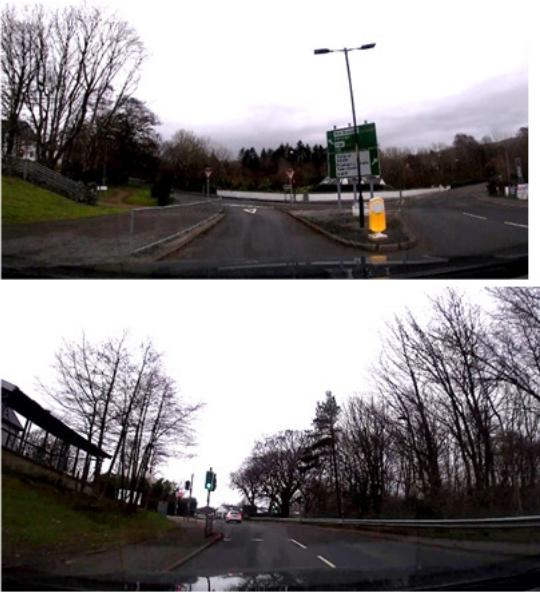
54 & 55	<p>A87 / A855 Junction</p>

<p>Loads will continue on the A87 northbound.</p> <p>A swept path assessment has been undertaken and indicates that the blade tip will over-sail the eastern verge prior to the junction, though no physical mitigation measures will be required.</p> <p>Loads will over-run and over-sail the splitter island where a load bearing surface should be laid, and one lighting column, one road sign, one lit road sign, and one bollard should be removed. Loads will over-run and over-sail the western verge where a load bearing surface should be laid, and the pedestrian guardrail and one lit road sign should be removed. The vegetation should be cleared. Loads should be raised on their suspension settings to over-sail the wall and embankment.</p> <p>Loads will over-sail the north-eastern verge following the junction, though no physical mitigation measures will be required.</p> <p>The tree canopy should be trimmed to ensure that there is a 5m clear head height. Trimming works can be subject to ecological time constraints and early engagement with the relevant authority is recommended.</p> <p>Swept path assessment SK36 is included in Appendix B.</p>

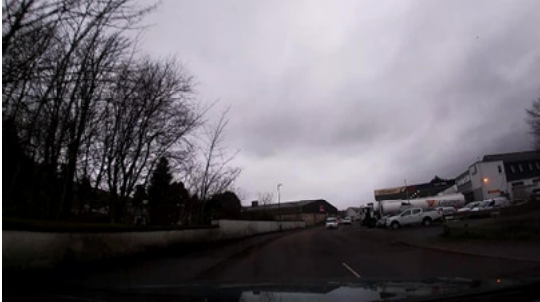
56	<p>A87 northeast of Sulaisiadar Mor</p>

<p>Loads will continue on the A87 northbound.</p> <p>A swept path assessment has been undertaken and indicates that loads will over-sail both verges through the bend, though no physical mitigation measures will be required.</p> <p>Swept path assessment SK37 is included in Appendix B.</p>

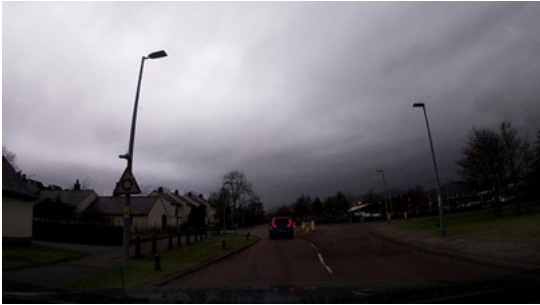
POI	Key Constraint	Details
57	A87 / Woodpark Road Roundabout

<p>Loads will take the second exit at the roundabout to continue on the A87 northbound.</p> <p>A swept path assessment has been undertaken and indicates that loads will over-sail the north-eastern verge prior to the roundabout, though no physical mitigation measures will be required.</p> <p>Loads will over-sail the south-western verge on entry to the roundabout where one bollard should be removed.</p> <p>Loads will over-sail the exit splitter island where one bollard should be removed.</p> <p>Swept path assessment SK38 is included in Appendix B.</p>
58	A87 Achtalean

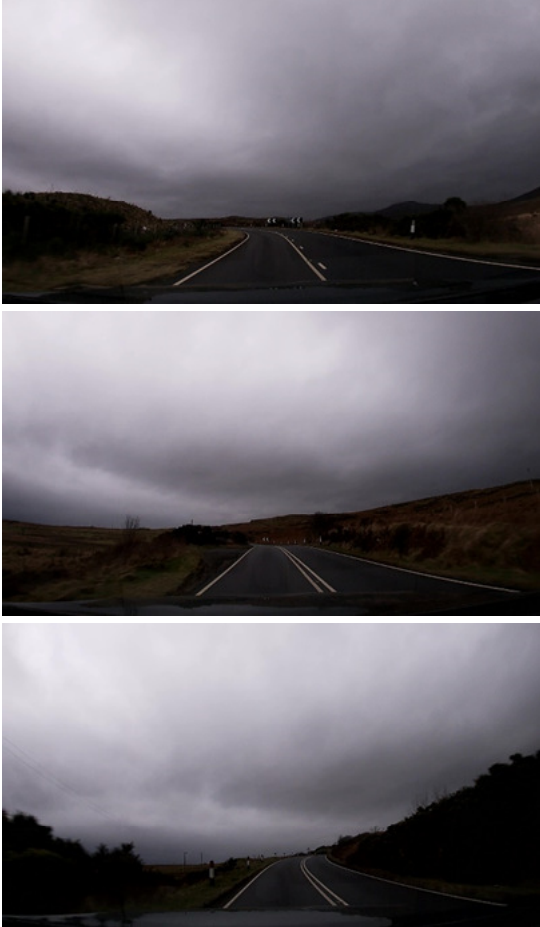
<p>Loads will continue on the A87 northbound.</p> <p>A swept path assessment has been undertaken and indicates that the blade tip will over-sail the bollards on the outside verge of the first left-hand bend where two chevron signs should be removed, and the vegetation should be trimmed. Loads will over-sail the inside verge where the vegetation should be trimmed.</p> <p>The vertical profile of the road at this location is pronounced and should be reviewed during the test run stage to ascertain if tar wedges will be required to prevent grounding.</p> <p>Swept path assessment SK39 is included in Appendix B.</p>

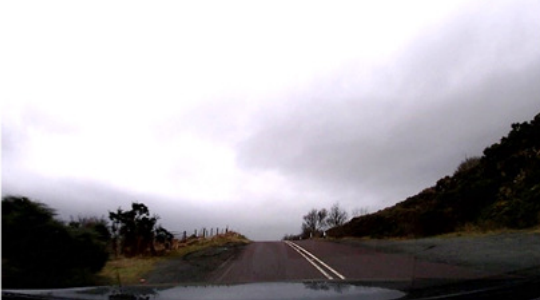
59	A87 northeast of Drumuie

<p>Loads will continue on the A87 northbound.</p> <p>A swept path assessment has been undertaken and indicates that no physical mitigation measures will be required.</p> <p>The vertical profile of the road at this location is pronounced and should be reviewed during the test run stage to ascertain if tar wedges will be required to prevent grounding.</p> <p>Swept path assessment SK40 is included in Appendix B.</p>

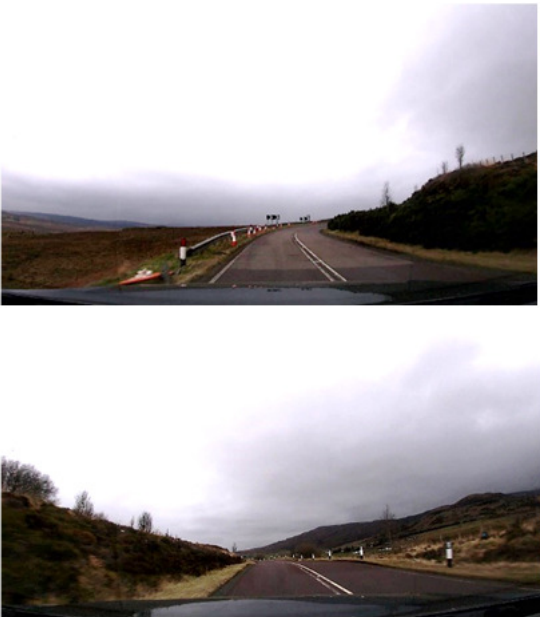
POI	Key Constraint	Details
<p>60 & 61</p>	<p>A87 Drumuie</p>

<p>Loads will continue on the A87 northbound.</p> <p>A swept path assessment has been undertaken and indicates that the blade tip will over-sail the bollards and safety barrier on the outside verge of the bend where four chevron signs should be removed. Loads will over-sail the inside verge where the vegetation should be trimmed.</p> <p>The vertical profile of the road at this location is pronounced and should be reviewed during the test run stage to ascertain if tar wedges will be required to prevent grounding.</p> <p>Swept path assessment SK41 is included in Appendix B.</p>
<p>62</p>	<p>A87 / A850 Junction</p>

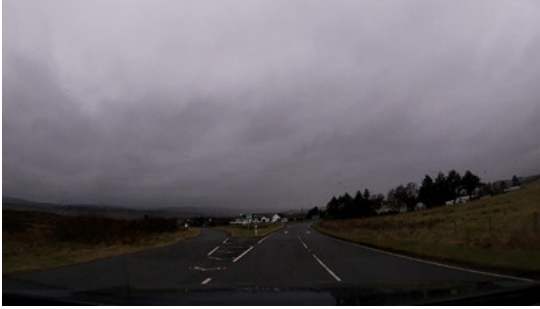
<p>Loads will turn left at the junction to exit the A87 and join the A850 westbound.</p> <p>A swept path assessment has been undertaken and indicates that loads will over-sail both verges through the bend. One road sign should be removed from each verge.</p> <p>Swept path assessment SK42 is included in Appendix B.</p>

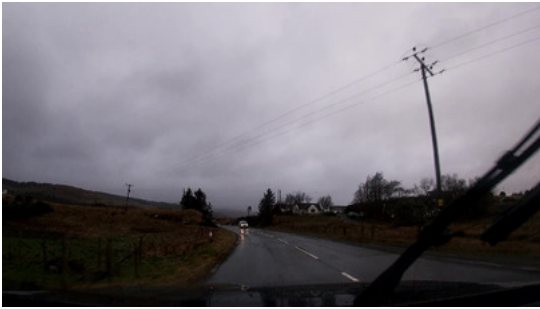
<p>63</p>	<p>A850 Peinmore</p>

<p>Loads will continue on the A850 westbound.</p> <p>A swept path assessment has been undertaken and indicates that loads will over-sail the inside verge of the second right-hand bend, though no physical mitigation measures will be required.</p> <p>The tree canopy should be trimmed to ensure that there is a 5m clear head height. Trimming works can be subject to ecological time constraints and early engagement with the relevant authority is recommended.</p> <p>Swept path assessment SK43 is included in Appendix B.</p>

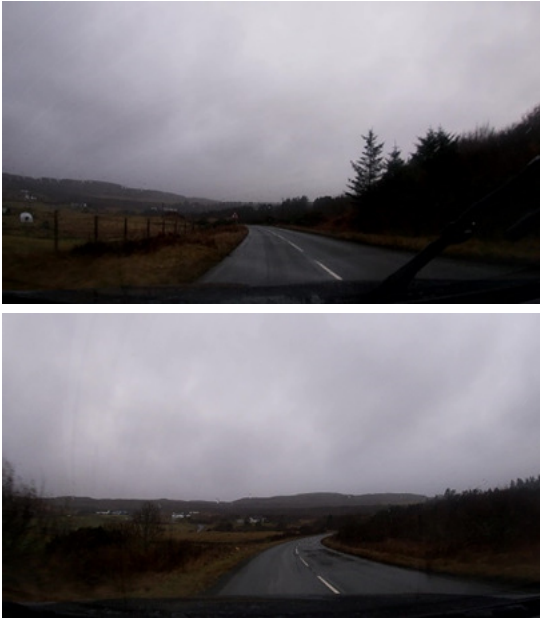
POI	Key Constraint	Details
<p>64 & 65</p>	<p>A850 Suledale</p>

<p>Loads will continue on the A850 westbound.</p> <p>A swept path assessment has been undertaken and indicates that the blade tip will over-sail the outside verge of the right-hand bend where the vegetation should be trimmed. Loads will over-sail the inside verge, though no physical mitigation measures will be required.</p> <p>Swept path assessment SK44 is included in Appendix B.</p>
<p>67</p>	<p>A850 Flashader</p>

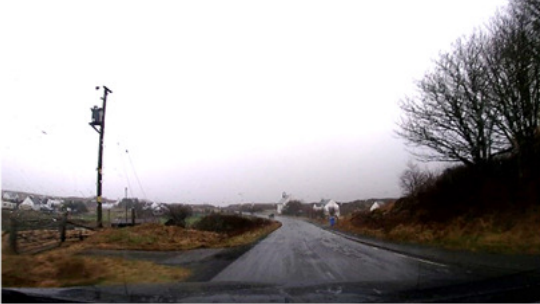
<p>Loads will continue on the A850 westbound.</p> <p>A swept path assessment has been undertaken and indicates that no physical mitigation measures will be required.</p> <p>Swept path assessment SK45 is included in Appendix B.</p>
<p>68</p>	<p>A850 Edinbane</p>

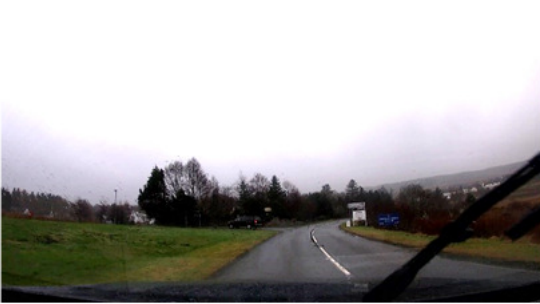
<p>Loads will continue on the A850 westbound.</p> <p>A swept path assessment has been undertaken and indicates that loads will over-sail both verges through the bend, though no physical mitigation measures will be required.</p> <p>Swept path assessment SK46 is included in Appendix B.</p>

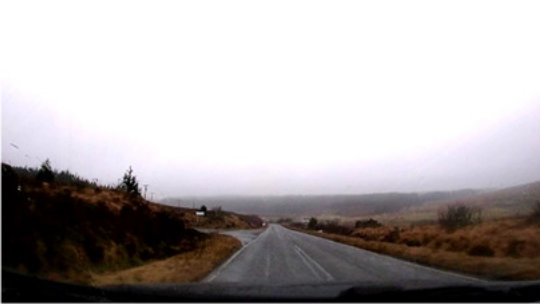
<p>69</p>	<p>A850 Ben Aketil Access Junction</p>

<p>Loads would turn left into the upgraded access junction for the operational Ben Aketil Wind Farm. The junction would need to be widened in accordance with Vestas guidelines and the requirements of The Highland Council.</p> <p>An extension to the existing load bearing area is required and two road signs should be relocated. Swept path assessment SK48 is included in Appendix B.</p> <p>Loads would then proceed to the turbine locations using an upgraded track as Ben Aketil was designed for Enercon E70 machines. The track would need to be upgraded to meet the V136 track specifications along its whole length.</p>
