TECHNICAL APPENDIX 11.3: HERITAGE WALKOVER SURVEY REPORTS

Balmeanach Wind Farm
Prepared for: **Balmeanach Wind Farm Limited**

SLR Ref: 428.V11223.00001
Version No: Final
July 2023

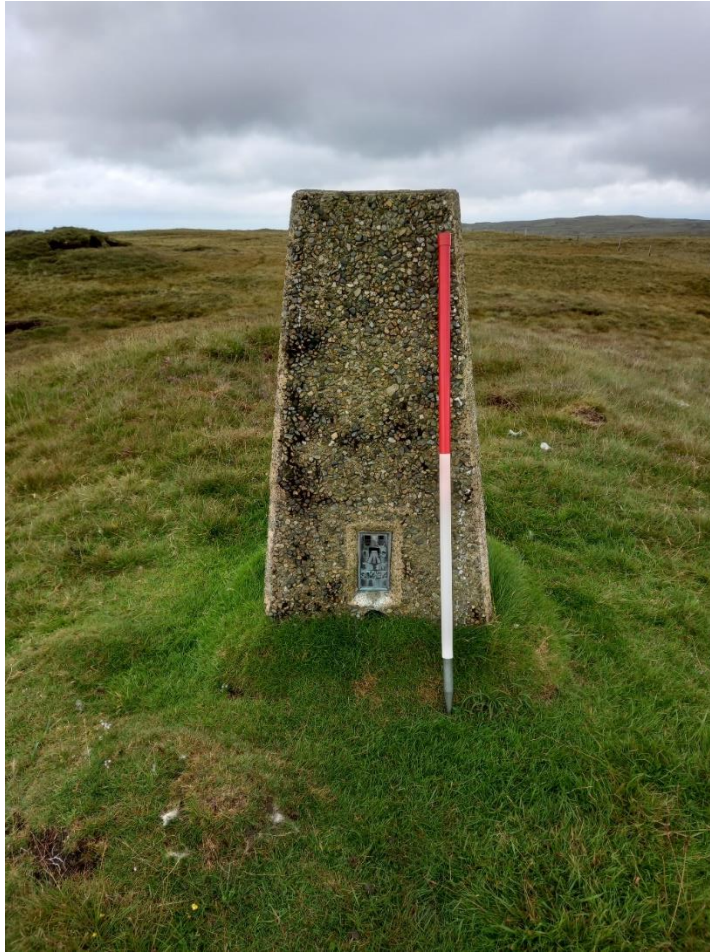
Plate 1: Modern OS concrete marker, facing north west.

The asset (**Plate 1**) consists of a concrete marker, 1.1m in height, 0.6m in length and 0.6m in width. It is marked with a metal OS benchmark. The feature marks the summit of Ben Aketil and is likely the triangulation station listed on the 1965 National Grid Map (NG34NW – A).

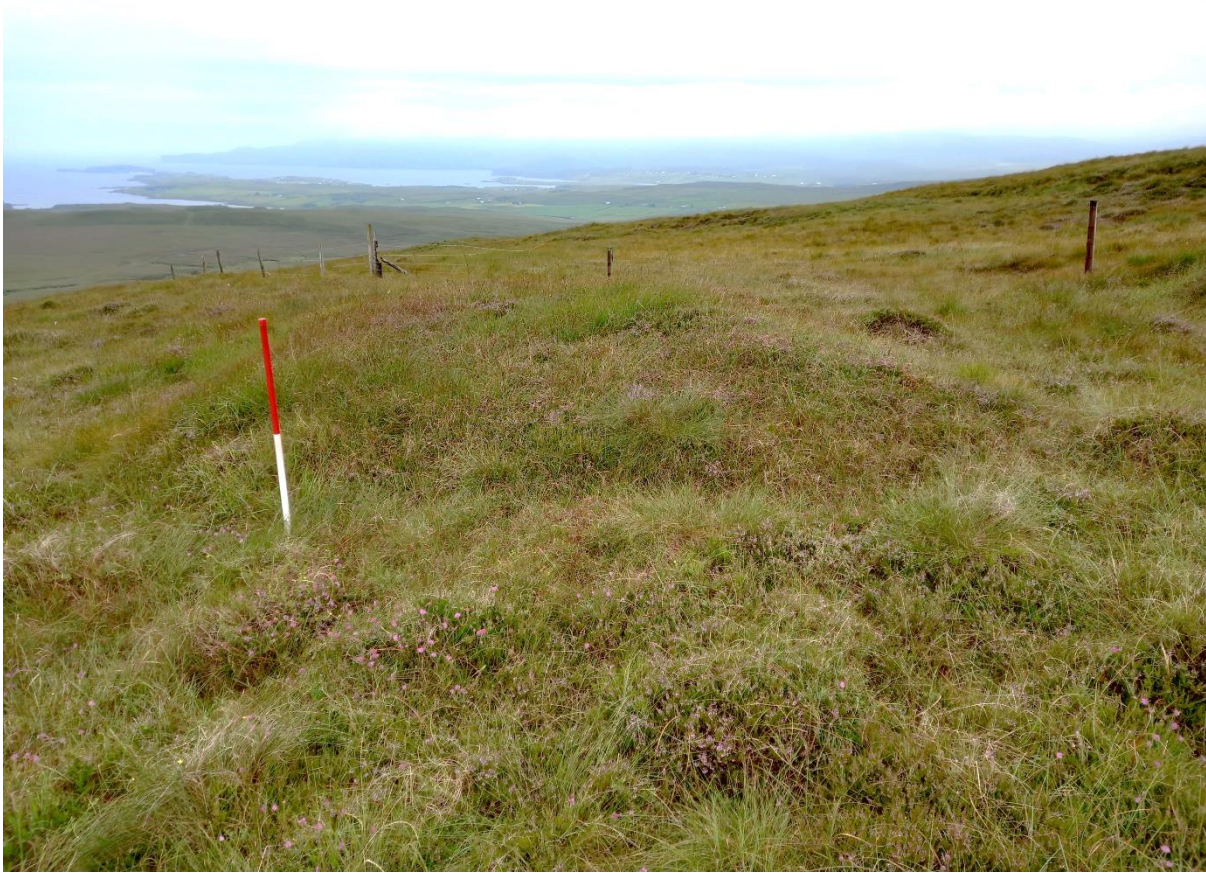
Plate 2: SLR49, unknown feature, facing south west.

SLR49 is an unknown feature, consisting of a raised mound, sub-rectangular in shape, 5m in length, 3m in width, and 0.5m in height. It has three defined sides to the north, east, and west, while the south side slopes more gently. There is evidence of a possible gully or ditch running round the feature. Vegetation covers the feature and has likely contributed to the overall poor condition of the feature, obscuring its original shape in such a way that provenance and purpose cannot be determined. It is located next to a boundary fence that runs along western edge of the inner site boundary.

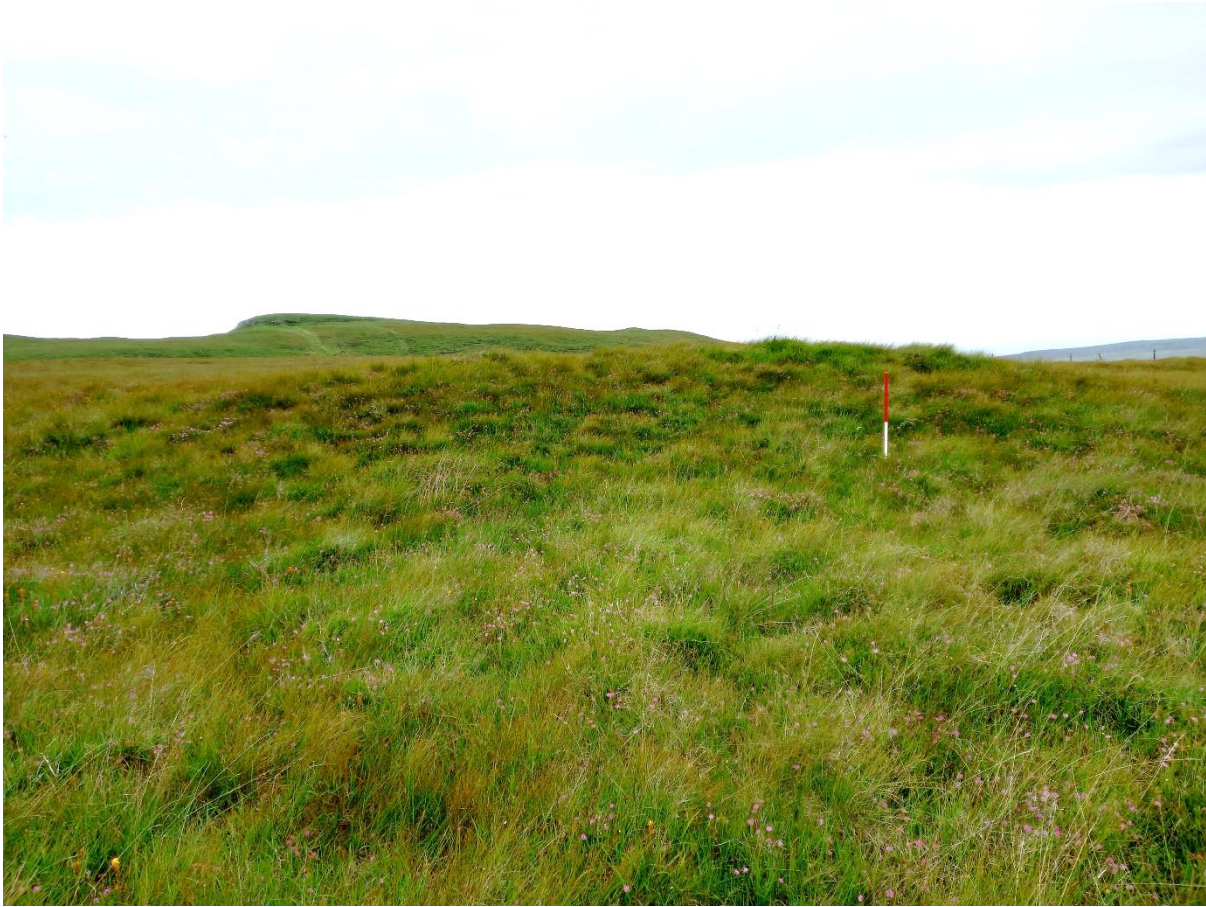
Plate 3: SLR50, headland/field boundary, facing south.

SLR50 consists of a large, raised mound, 11m in length, 5m in width, and 0.75m in height, sub-ovoid in shape. The shape of the feature and its place in a flat area of ground suggest this is likely a headland marking the boundary of agricultural land. Overall, the feature is well defined though it is covered in vegetation which obscures any opportunity to identify individual rocks or other materials making up the headland. The condition is therefore moderate.

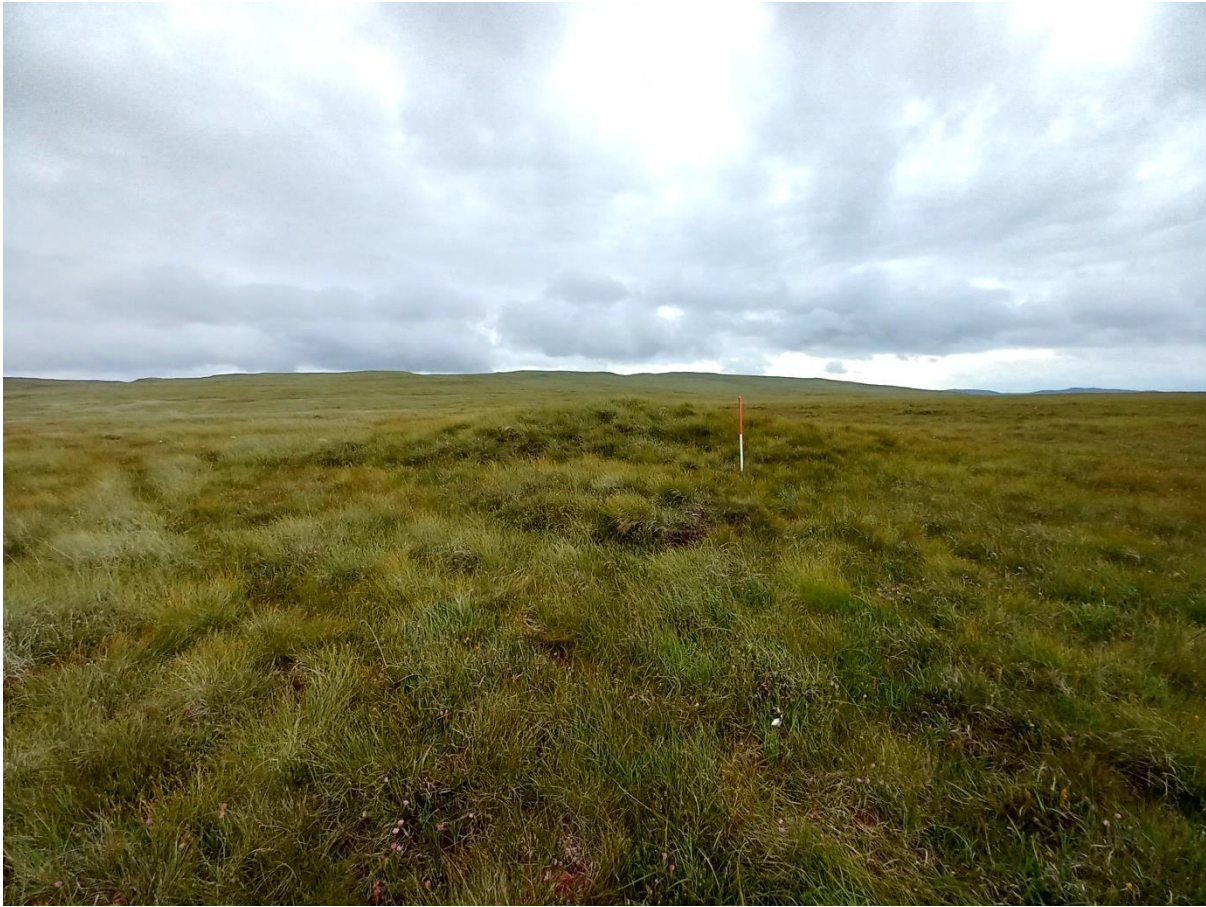
Plate 4: SLR51, headland/field boundary, facing north.

SLR51 consists of a large, raised mound, sub-ovoid in shape, 15m in length, 8m in width, and 0.75m in height. The shape of the feature and its position in a flat area of the landscape suggest this is a headland marking the boundary of agricultural land. It is similar to **SLR13**, which is located 200m to the west. Like **SLR13** the feature is well defined though it is covered in vegetation which obscures any opportunity to identify individual rocks or other materials making up the headland. The condition is therefore moderate.

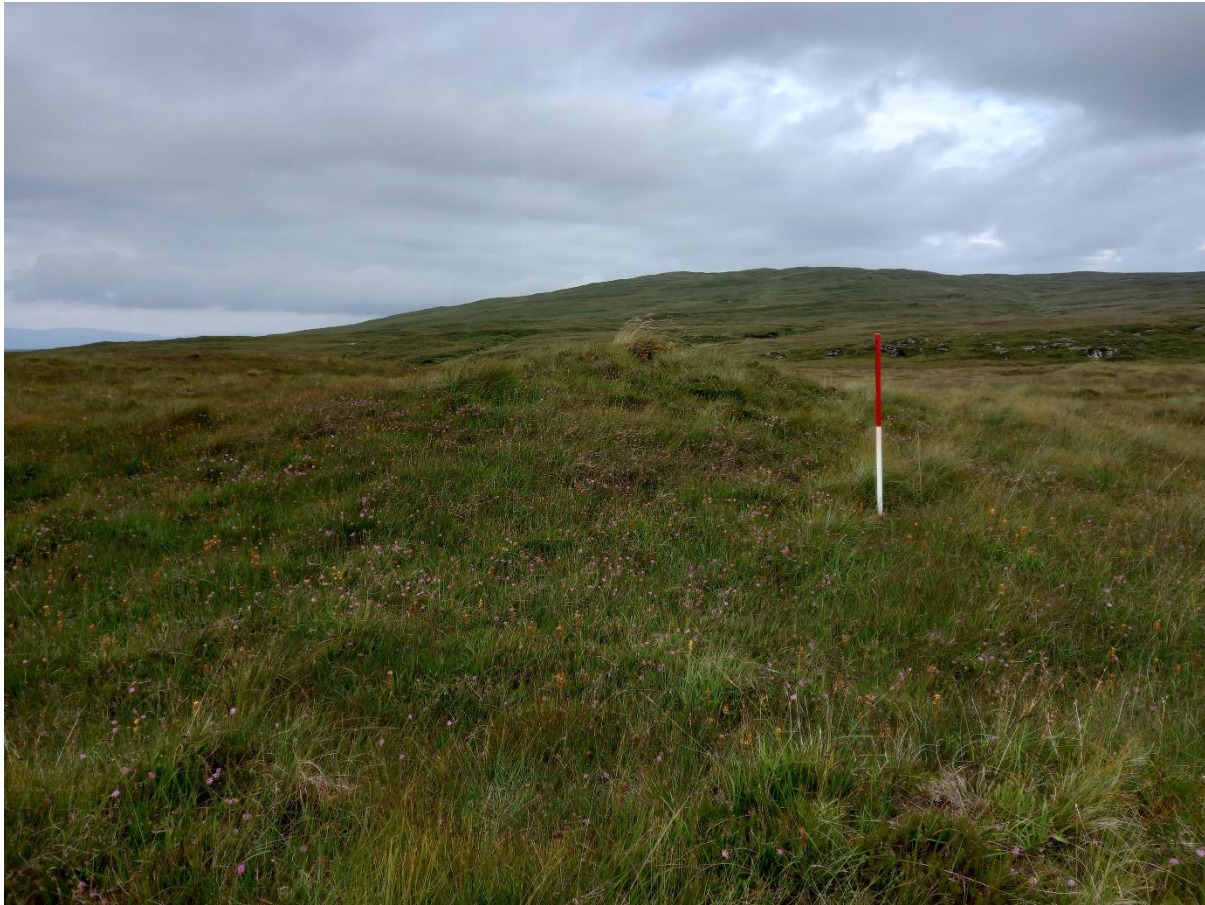
Plate 5: SLR52 clearance cairn, facing east

SLR52 is an overgrown clearance cairn, with a sub-ovoid shape, far steeper on west side, smoothing out on the east side. 6.5m in length, 4m in width, and 0.5m in height. The cairn is completely overgrown with vegetation and no individual stones can be identified, so the condition is assessed as poor.

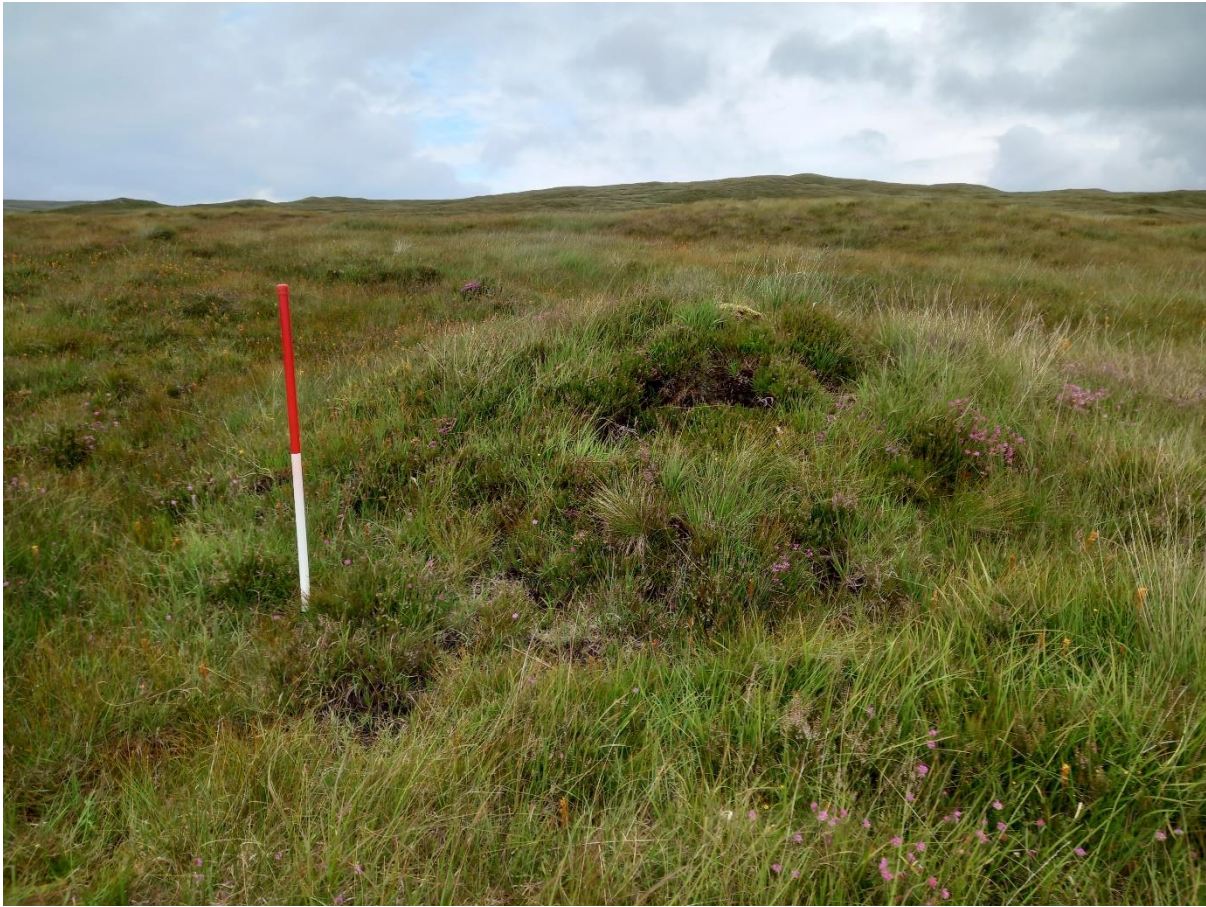
Plate 6: SLR53, possible burnt mound, facing west.

SLR53 is a small possible burnt mound, circular in shape, 3m in length, 3m in width, and 0.6m in height. Situated on the edge of a peat bog, the soil and peat that make up the mound appear darker than the surrounding ground, suggesting the possibility of burning or charcoal. It is heavily overgrown with large grass tufts and heather obscuring much of the original shape of the feature, and the condition is therefore assessed as poor.

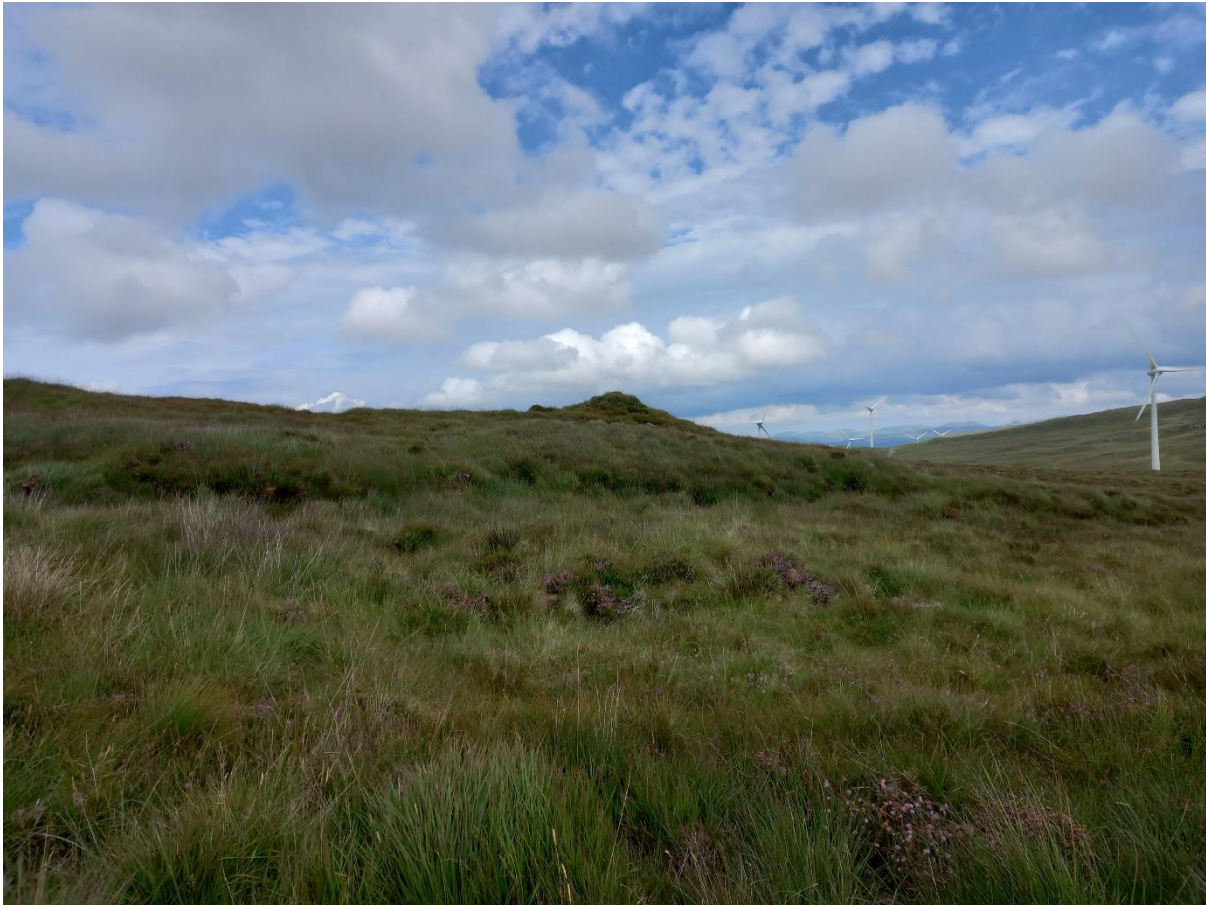
Plate 7: SLR54, possible cairn, facing north east.

SLR54 is a possible cairn. It could not be approached due to a barbed wire fence and uncertainty over access permissions. Though only visible from a distance, appears well defined and distinct in the landscape, though overgrown with vegetation, and its condition is likely good.

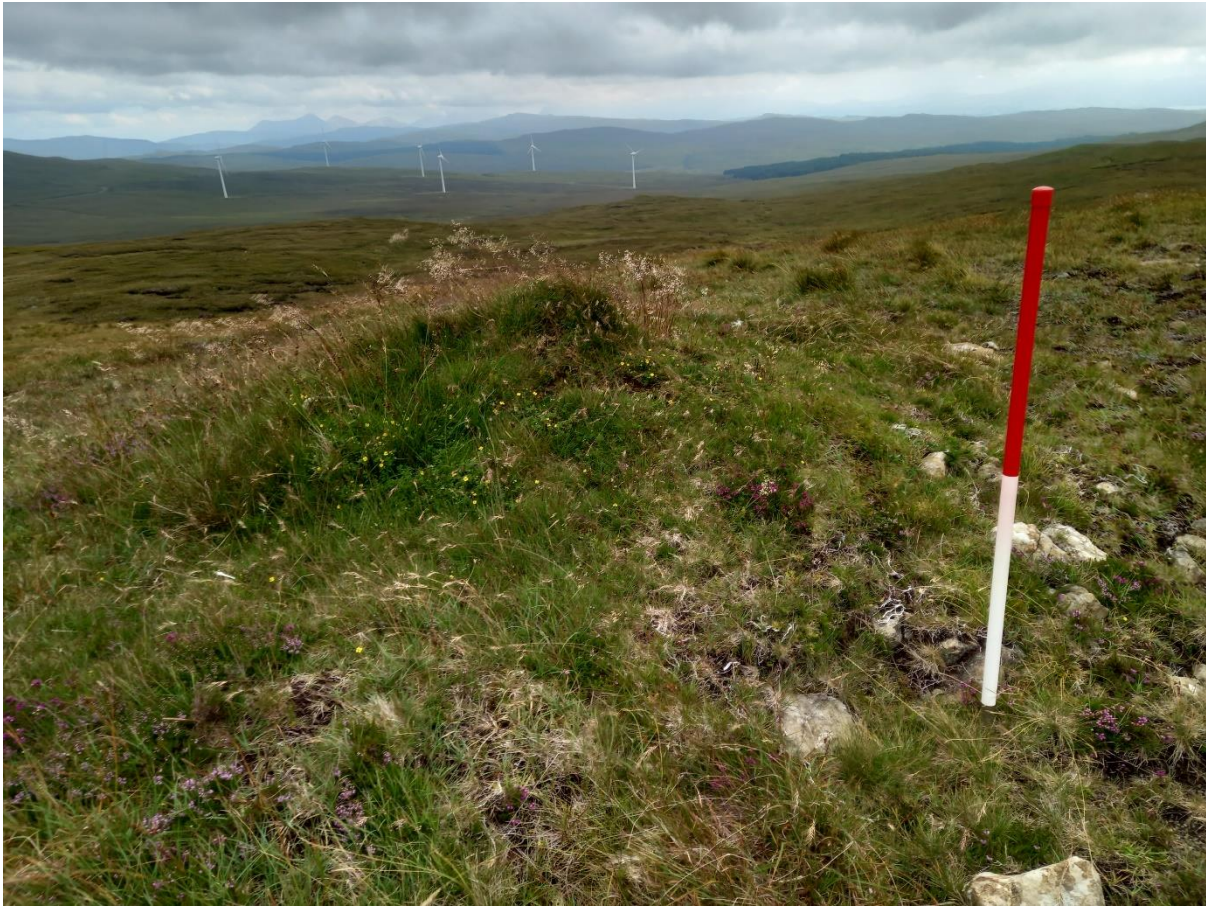
Plate 8: SLR55, overgrown clearance cairn, facing south east

SLR55 is a small possible heavily overgrown cairn to the south of the summit of Ben Sca. It is 3m in length, 3m in width, and 0.5m in height. Some individual stones are identifiable on the cairn but it is heavily overgrown. The area around the cairn is eroded away due to animal activity, and it appears the cairn has been partially robbed out by this activity, making the overall condition of this feature poor.

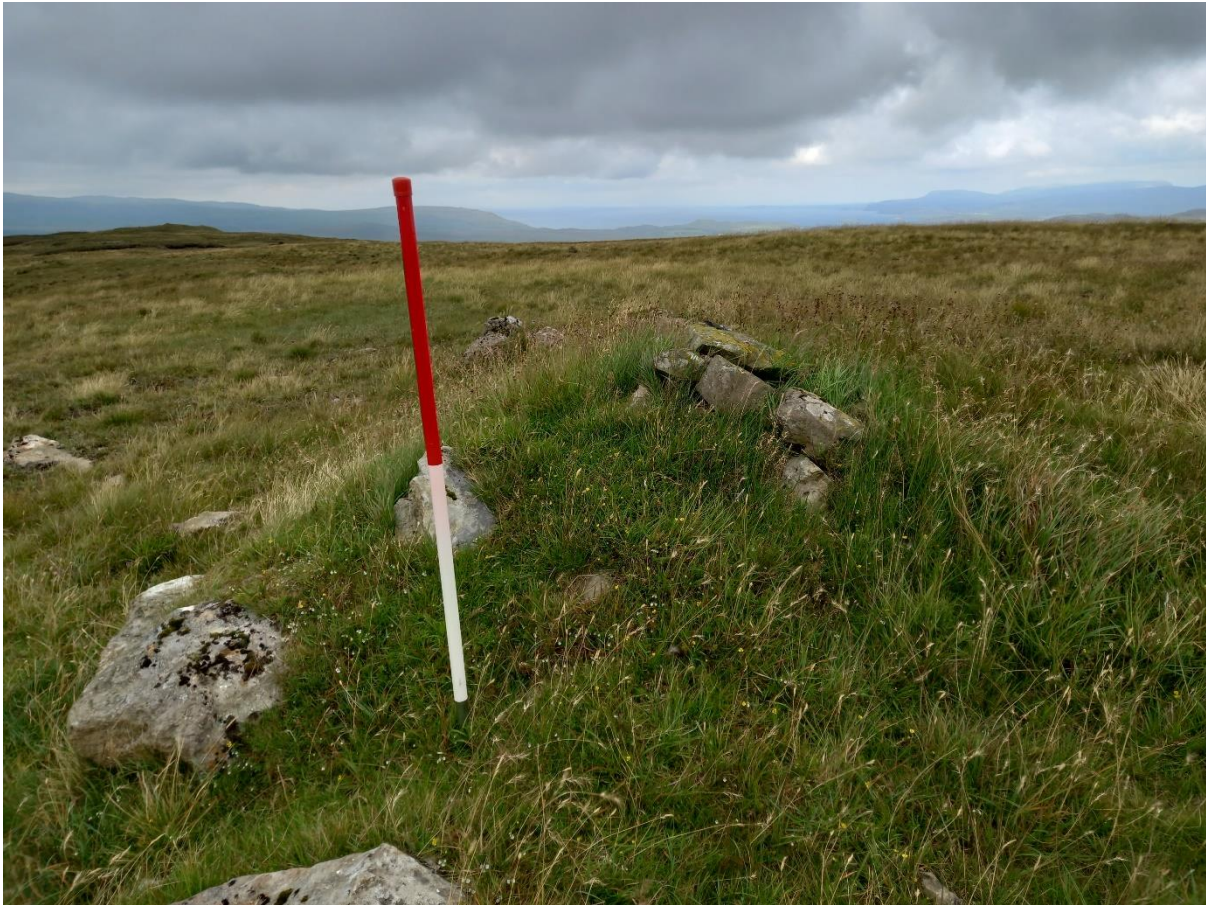
Plate 9: SLR56, Cairn at summit of Ben Sca, facing north

SLR56 is a small pile of rocks just to the south of the summit on Ben Sca. A cairn is listed at this location on the OS map, though no asset has previously been recorded on the HER or Canmore databases. 4m in length, 4m in width, and 0.75m in height. It is heavily overgrown with vegetation but 10 distinct stones are visible at the top of the cairn where the grass is thinner, and the overall condition of the feature is assessed as moderate.

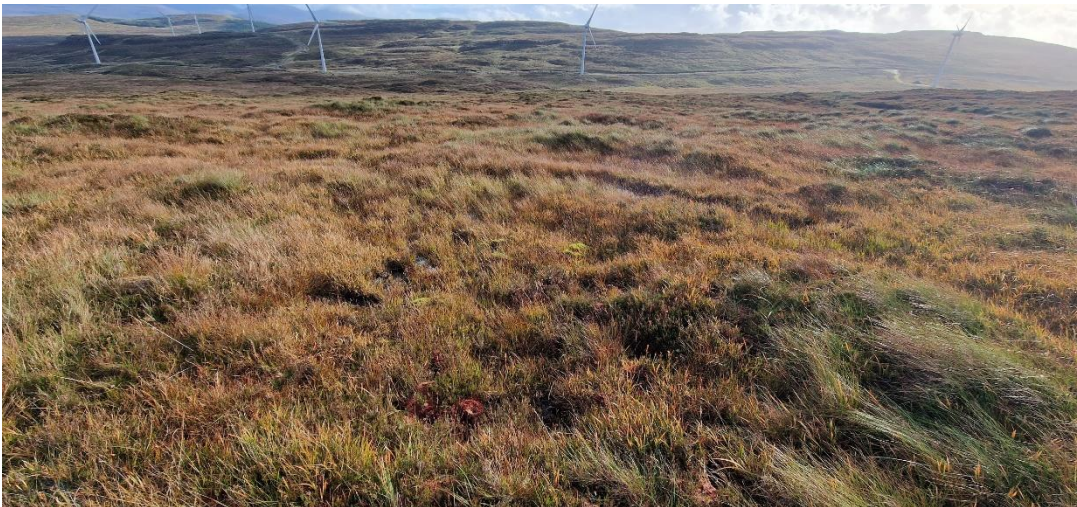
Plate 11: East facing view toward the location of Turbine 1, with views of Edinbane Wind Farm. No archaeological features were present.

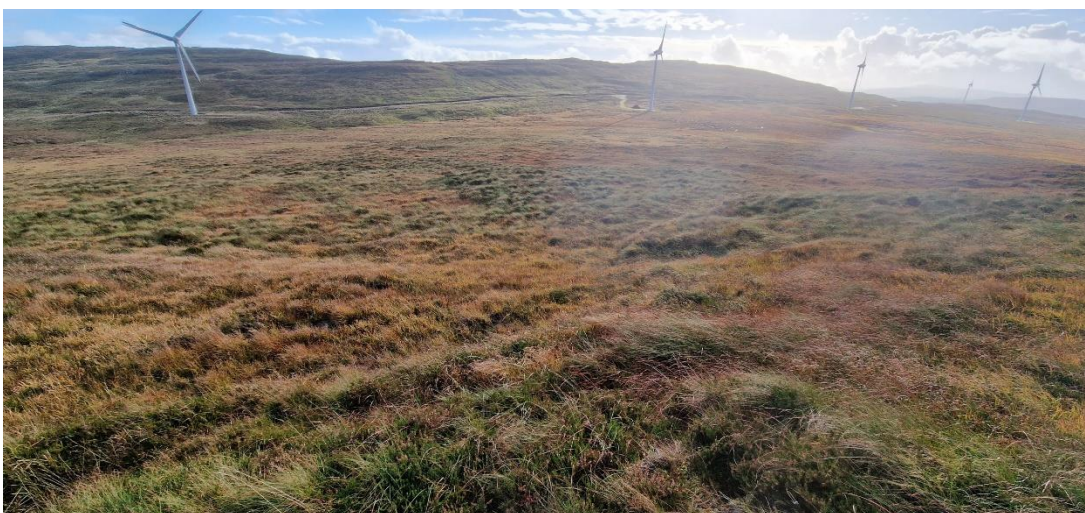
Plate 10: Easting facing view toward the location of Turbine 2, with views of Edinbane Wind Farm. No archaeological features were present.

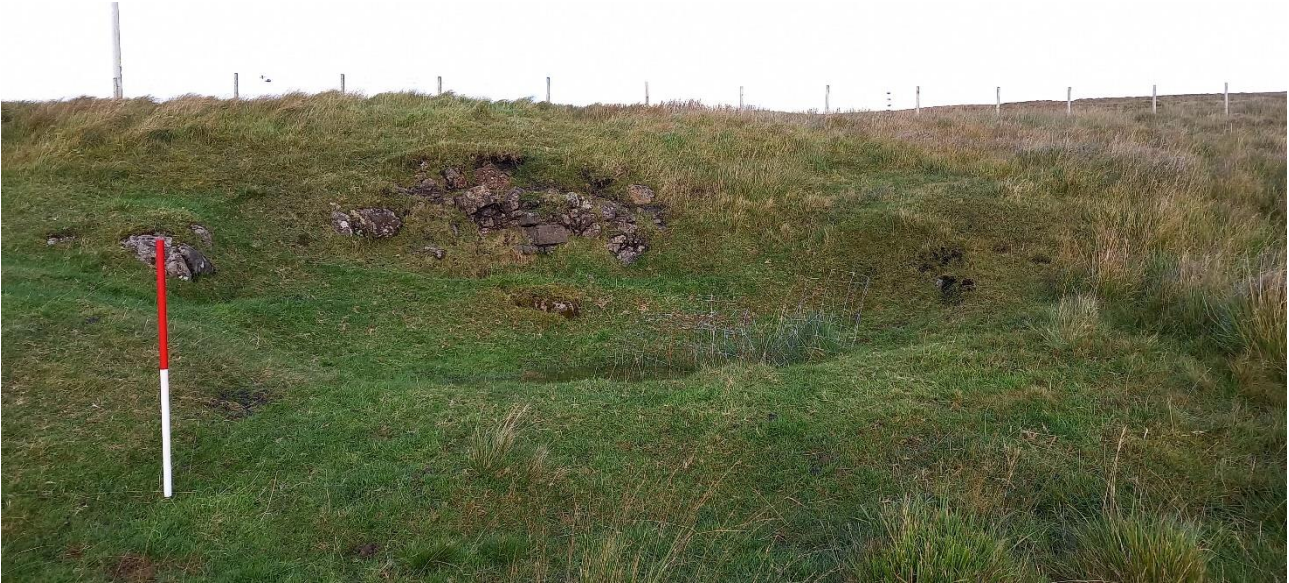
Plate 16: SLR401

A potential quarry pit was identified within the south of the scoping site boundary. It is approximately 3m wide by 4m in length and covered by turf.

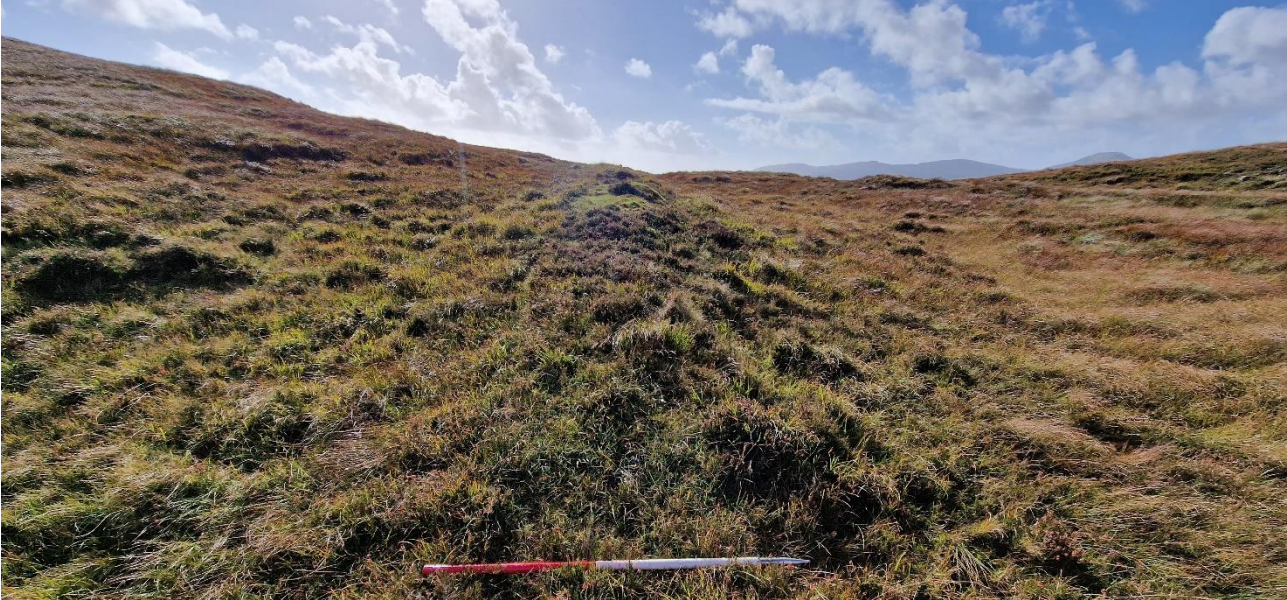
A linear feature, likely a field or land boundary, was identified within the west of the site. The feature was orientated north east to south west, approximately 1m in width and 50cm in height where visible, with noticeable breaks. The feature, visually, comprised turf. The feature is recorded on the OS 1:50k mapping, but not historic mapping, where it appears to c.400m in length.

Plate 17: SLR402, looking to south west.

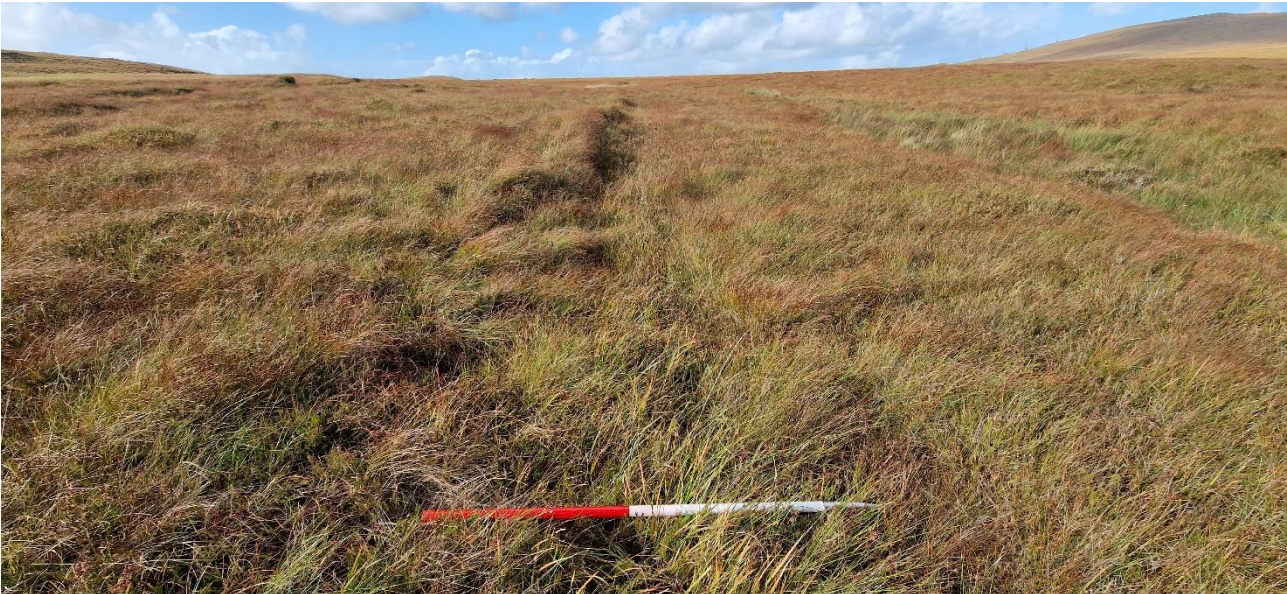
A ditch was identified in the central lower area of the valley. It was approximately 0.5m in depth, and 0.4m wide.

The visible portion of the ditch was approximately 10m in length, turning to the west at the northern end and terminating abruptly. This feature was positioned perpendicular to SLR402 and located within its path, although the features weren't physically connected. The ditch was in an area which was fairly waterlogged with numerous streams, with a shallow watercourse c.3m to the east, but the ditch itself didn't seem waterlogged.

Plate 18: SLR403, looking to the north.

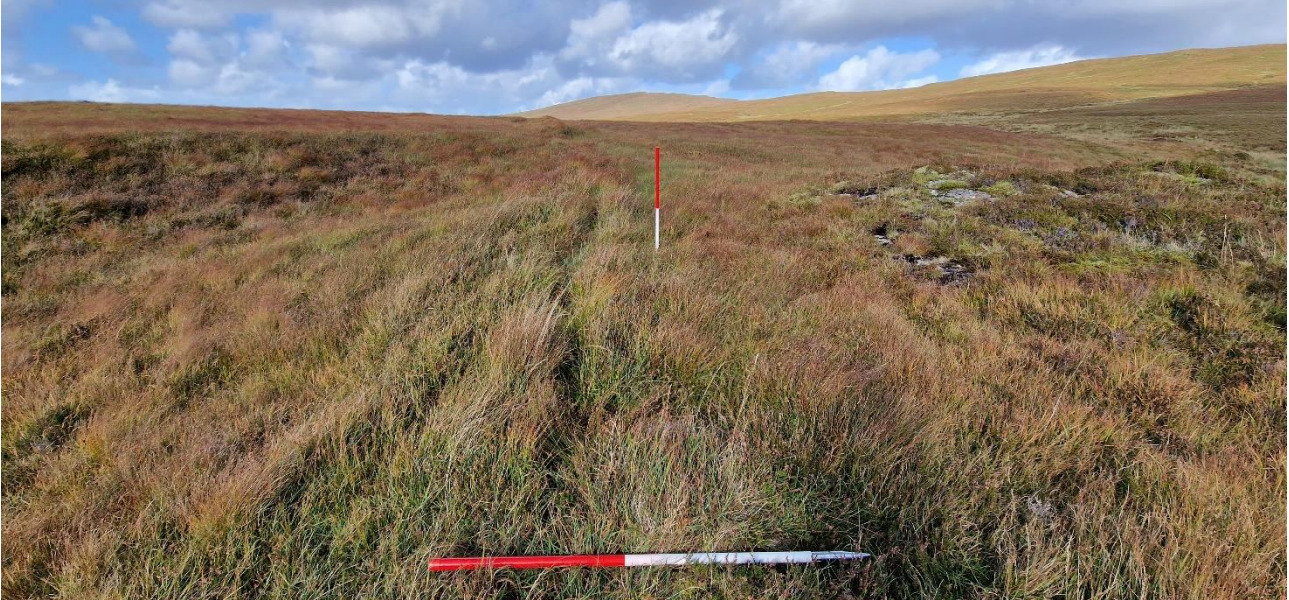
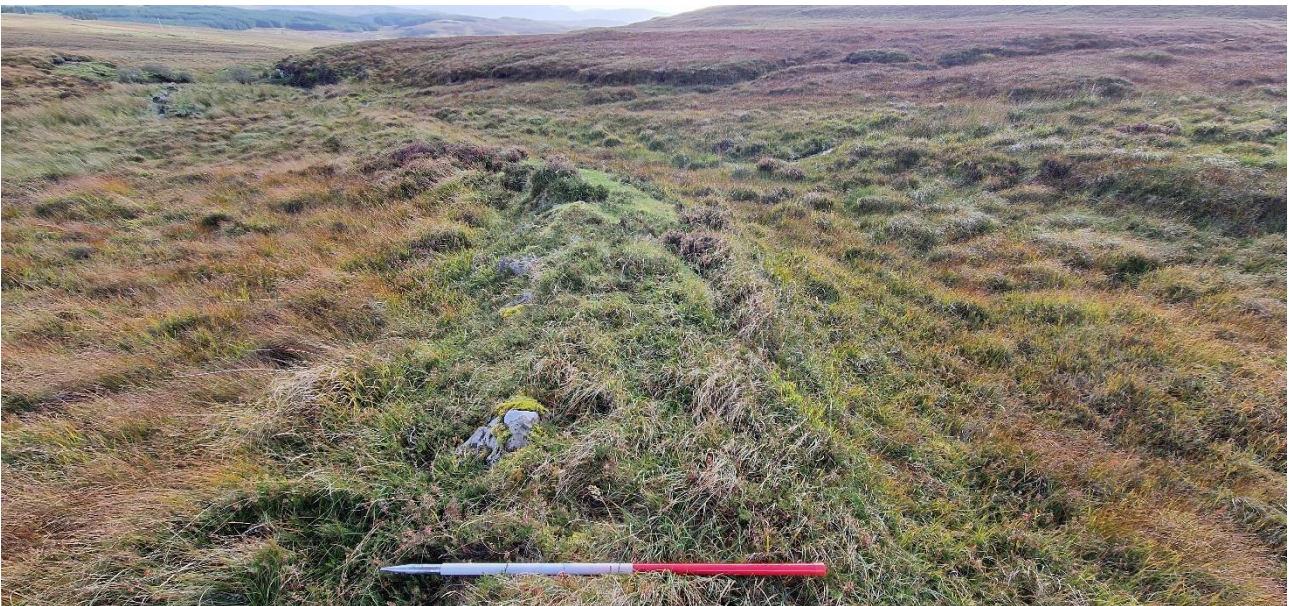
A linear feature, running north to south, was identified, comprising of turf with some loose stone inclusions in sections. The feature measured approximately 0.4m in height, 1m wide on average, and visible for approximately 15m. The feature is potentially a field boundary.

Plate 19: SLR404, looking to the north.

Plate 20: SLR404, looking to the south.

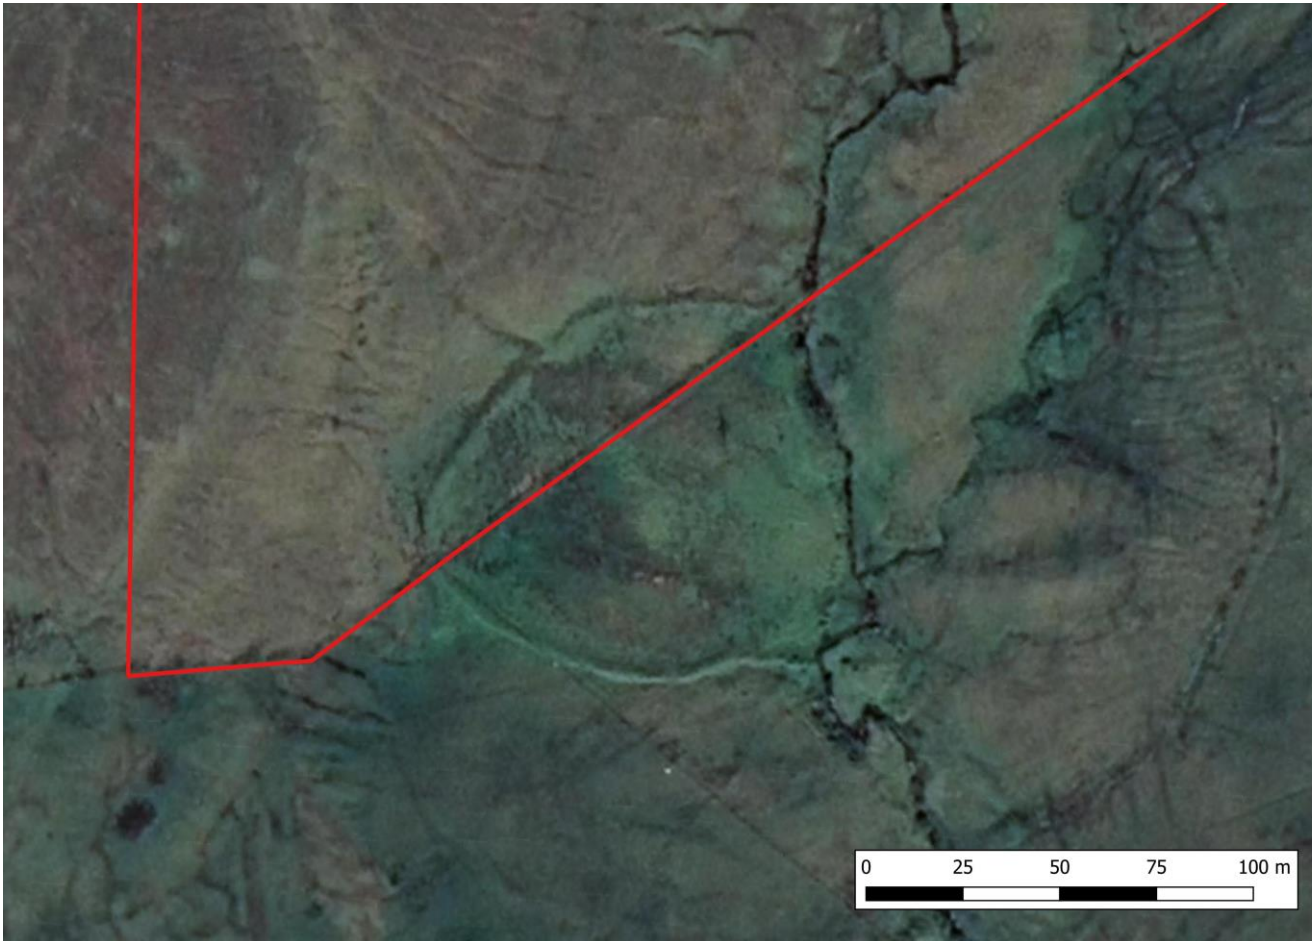
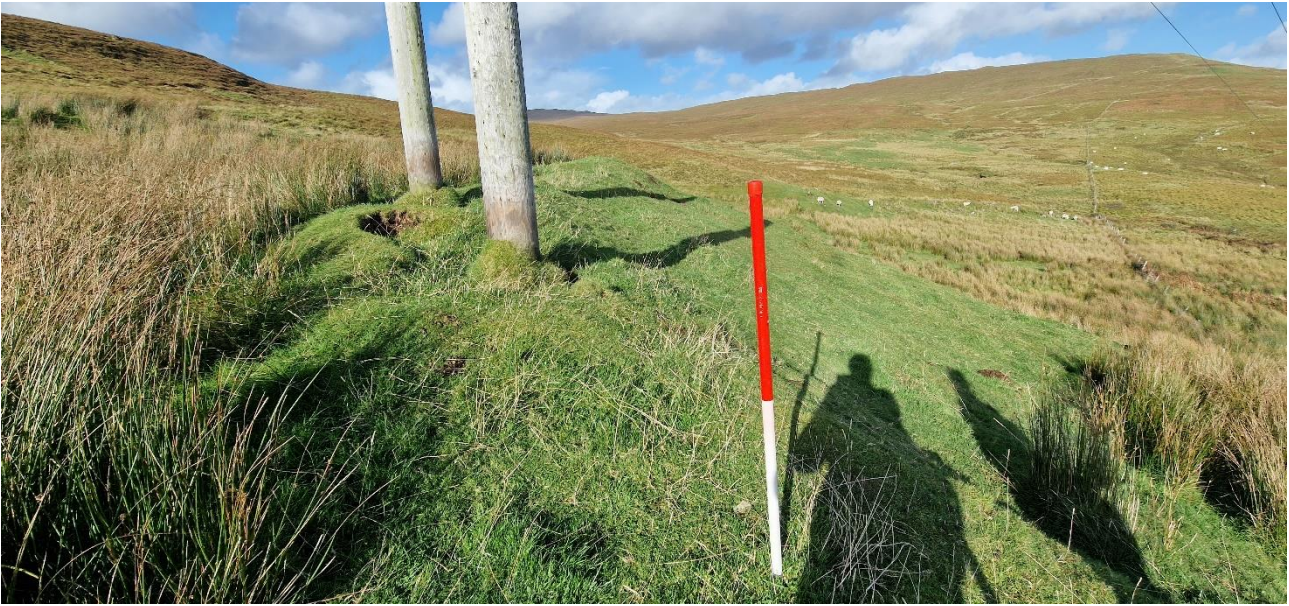
A C shaped enclosure was identified on satellite imagery and confirmed during the walkover survey. The asset is located along the western bank of Abhainn Bhaile Mheadhonach, which forms the eastern boundary. The asset is approximately 130m in length and is located on a steep slope, comprising a distinctive bank.

Plate 21: Google Earth (2022), showing SLR405 and the southern part of the scoping site boundary.

Plate 22: A portion of SLR405, looking to the north.

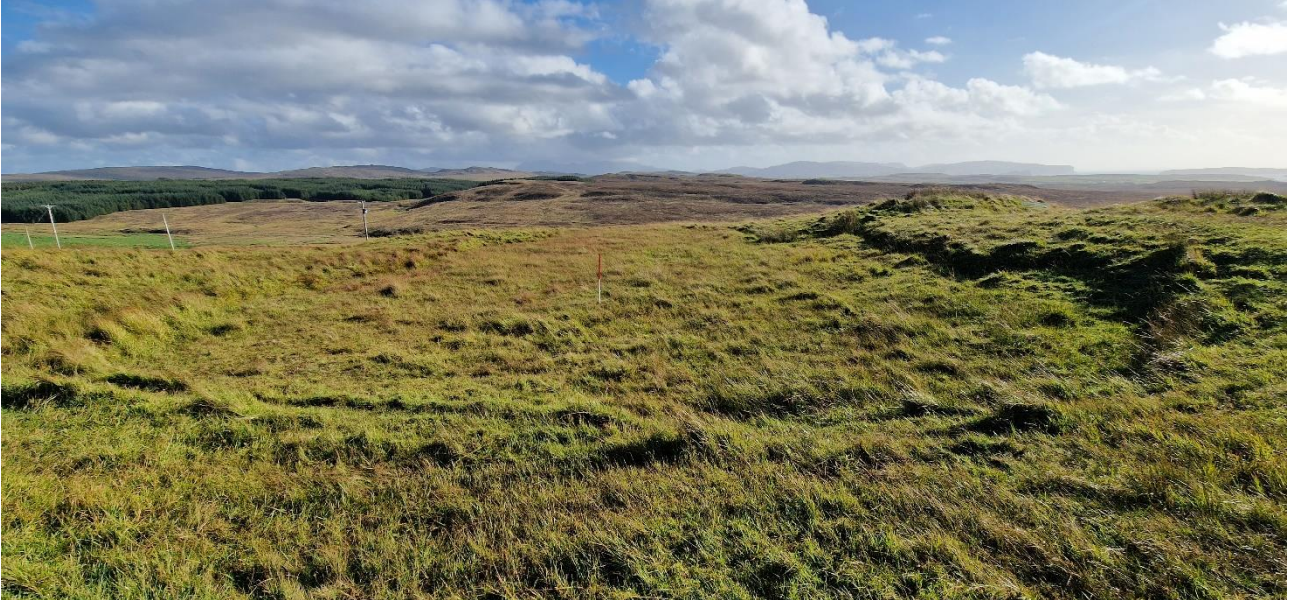
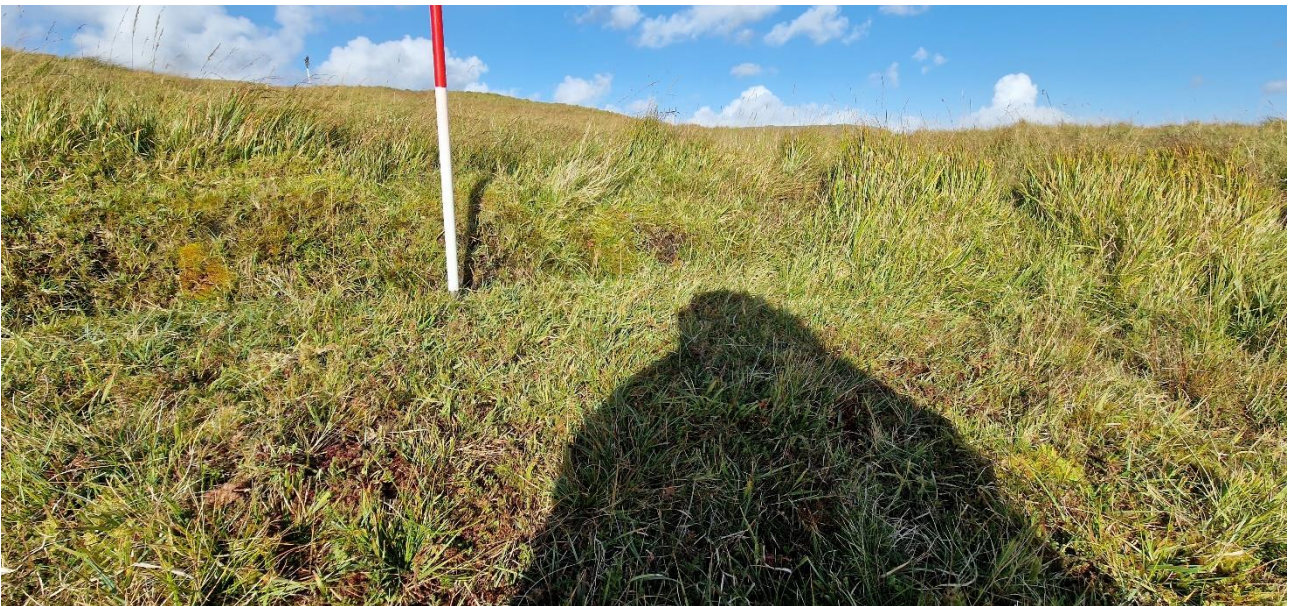
A circular cut in the topography was identified during the walkover. The feature was approximately 10m in diameter, and 0.25m in depth. Due to the soil composition of the site, it is possible that this is an area of peat cutting.

Plate 23: SLR406, looking to the south

Plate 24: Cut of SLR406
