Drummarnock Wind Farm – Further Environmental Information

Technical Appendix 1: Borrow Bit Appraisal

Preliminary Borrow Pit Appraisal

Site Walkover 18/01/2023

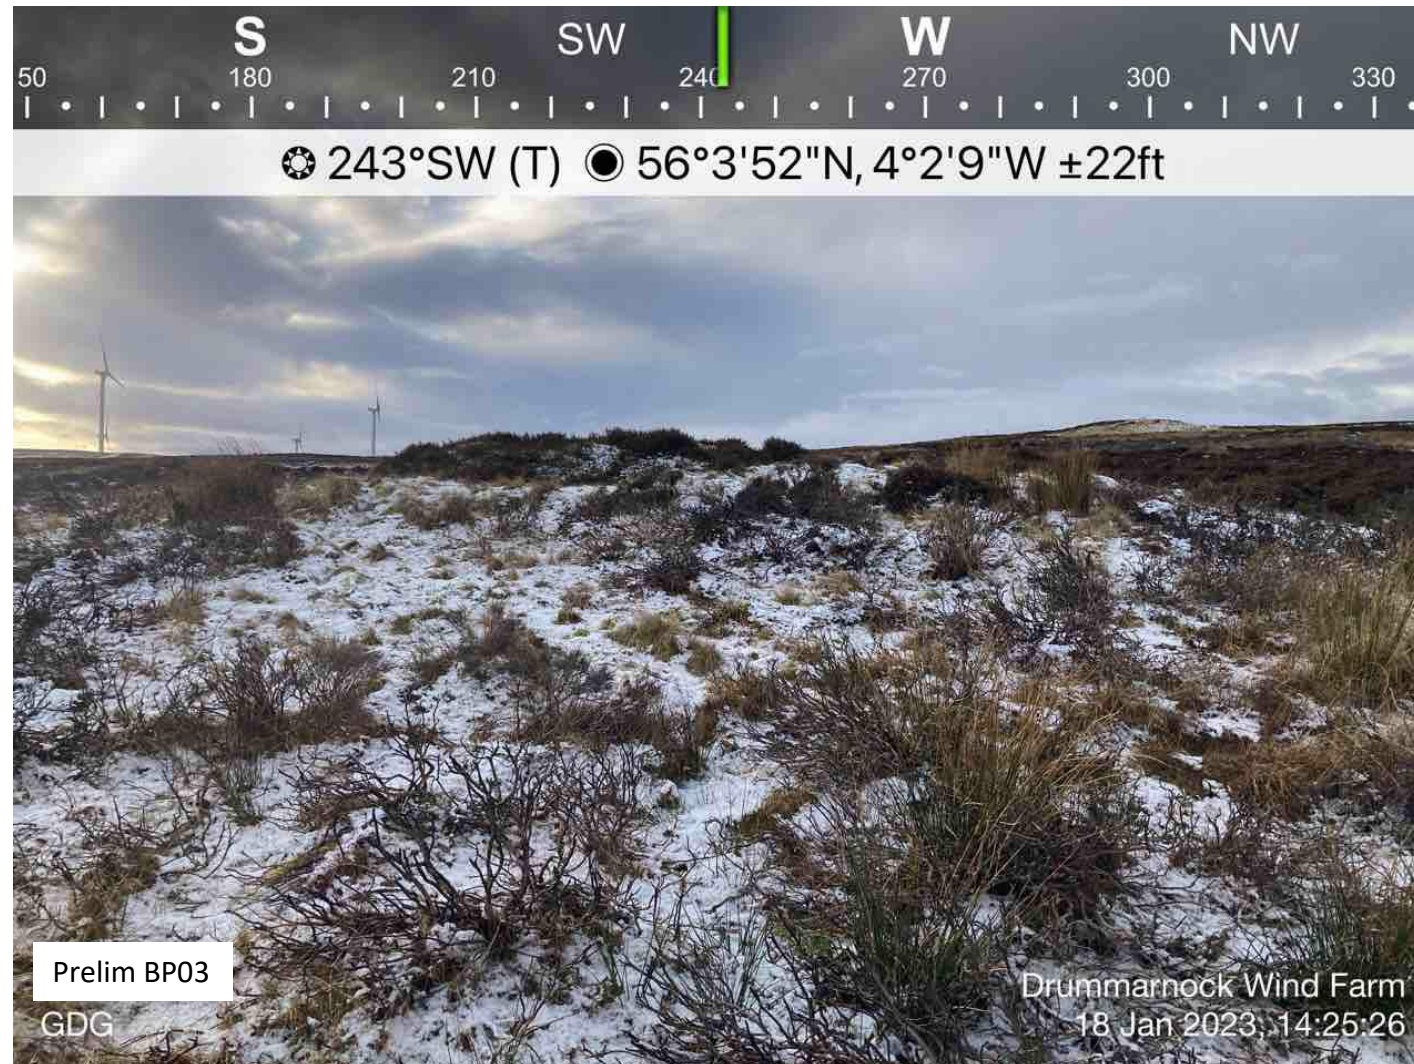
Photograph 13: View west upslope at a ridge in Prelim BP03.

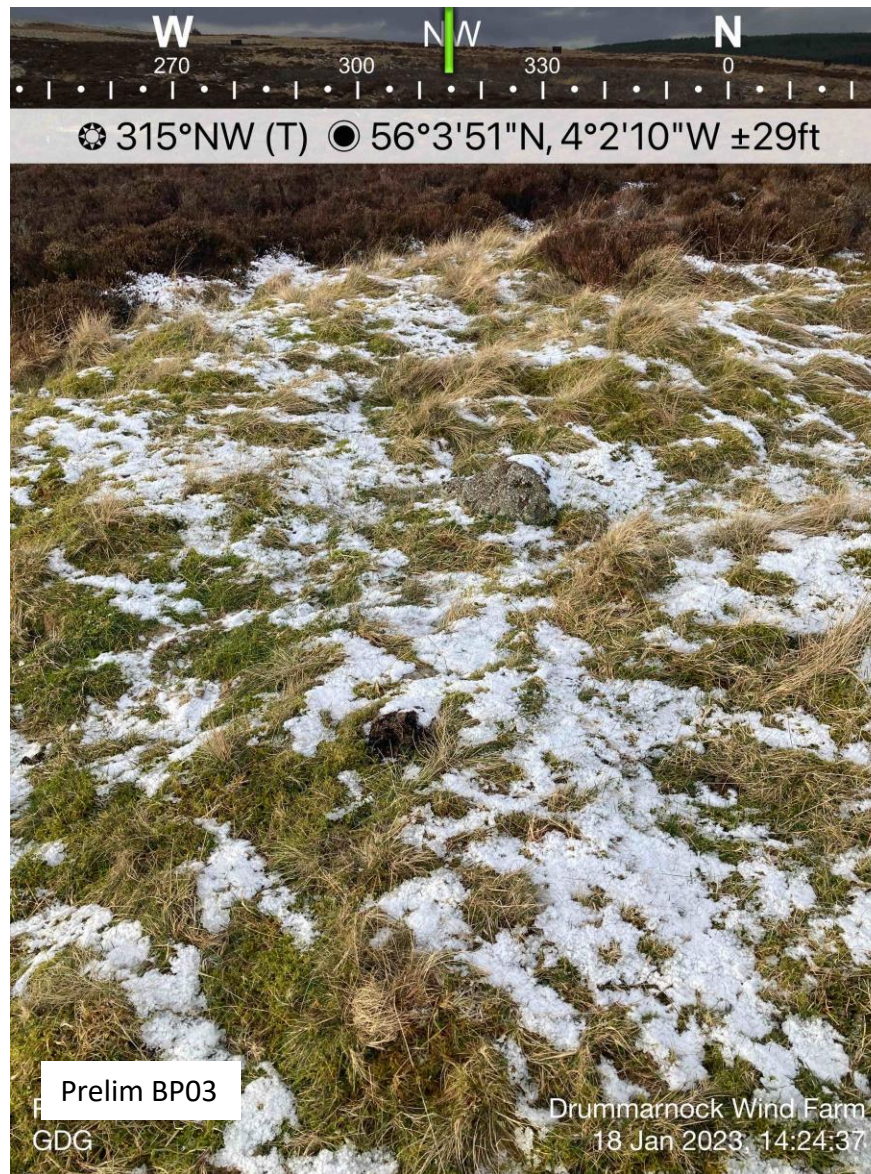
Photograph 14: Rock outcrop exposed within Prelim BP03

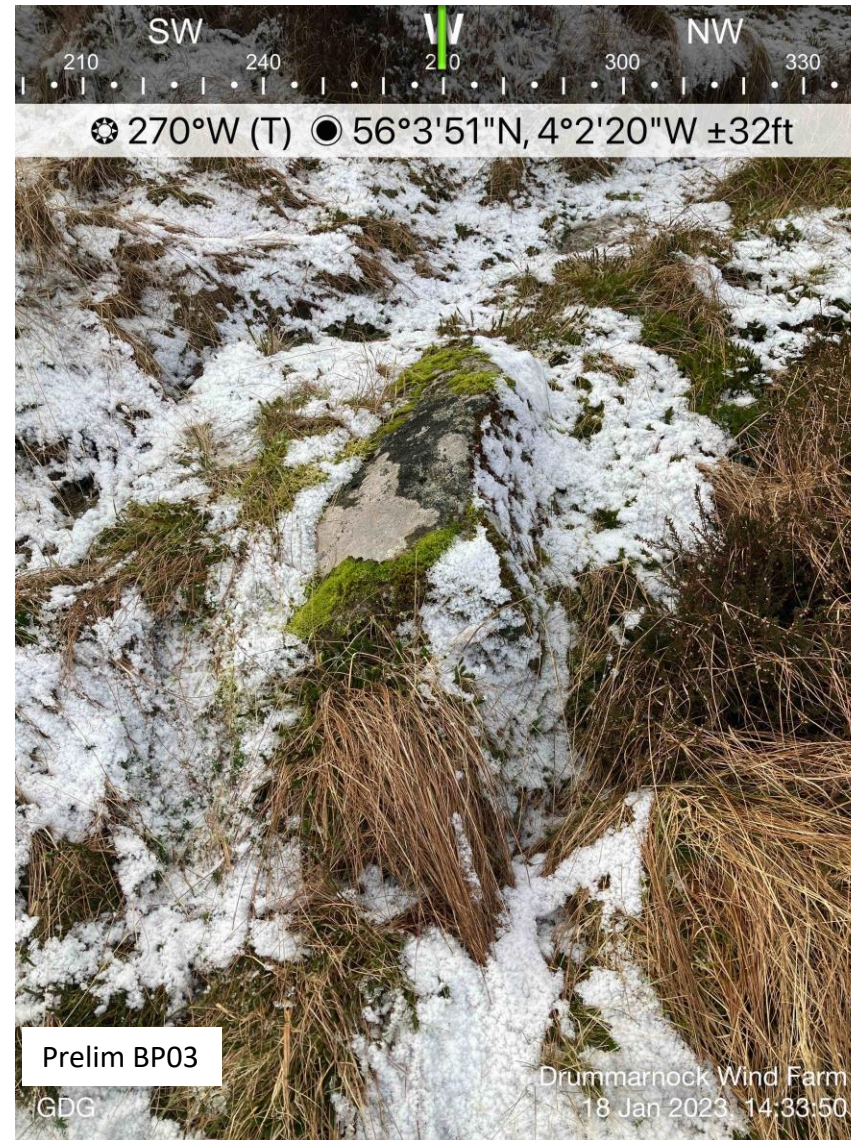
Photograph 15: Weathered rock exposed in Prelim BP03.
