Drummarnock Wind Farm

Technical Appendix 3-1: Borrow Bit Appraisal

Drummarnock Wind Farm Limited

Preliminary Borrow Pit Appraisal

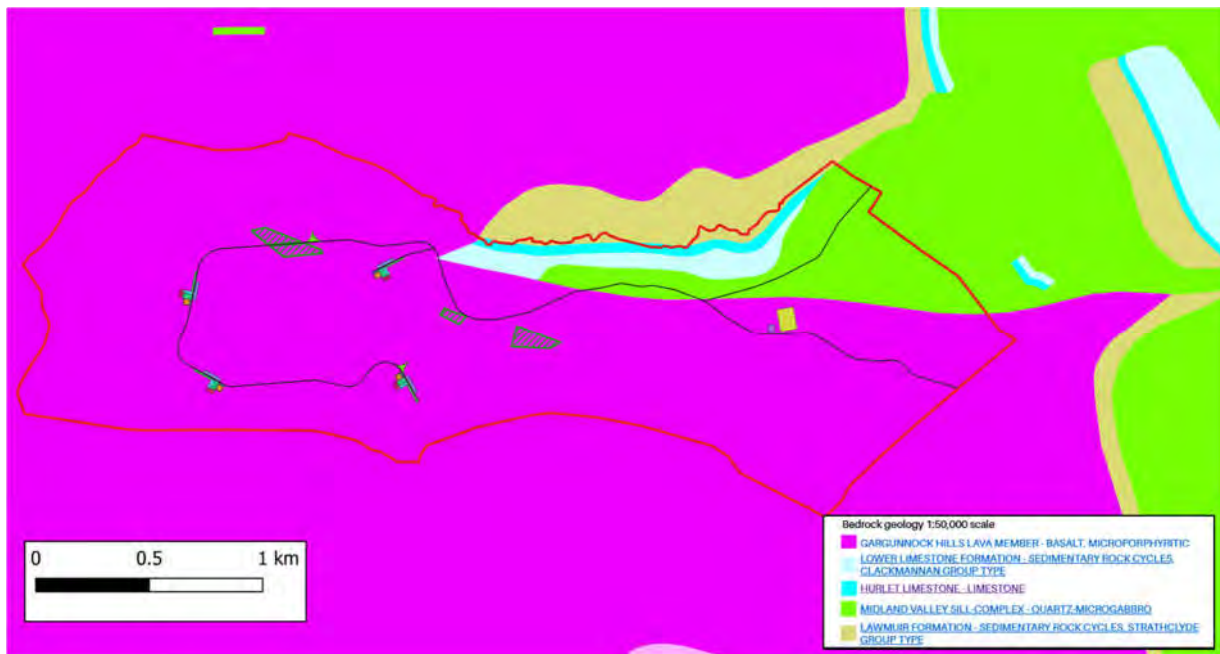
Figure 2-3 Bedrock Geology (1:50,000 Maps- BGS 2022)

A review of the British Geological Survey found the bedrock underlying the site comprises the following geological units outlined in Table 2-1 and shown in Figure 2-3. The two main geological units

beneath the site comprise basaltic and gabbroic rock, both of which are likely to produce an adequate material for general fill purposes, as the BGS classify as both rock types as typically very strong.

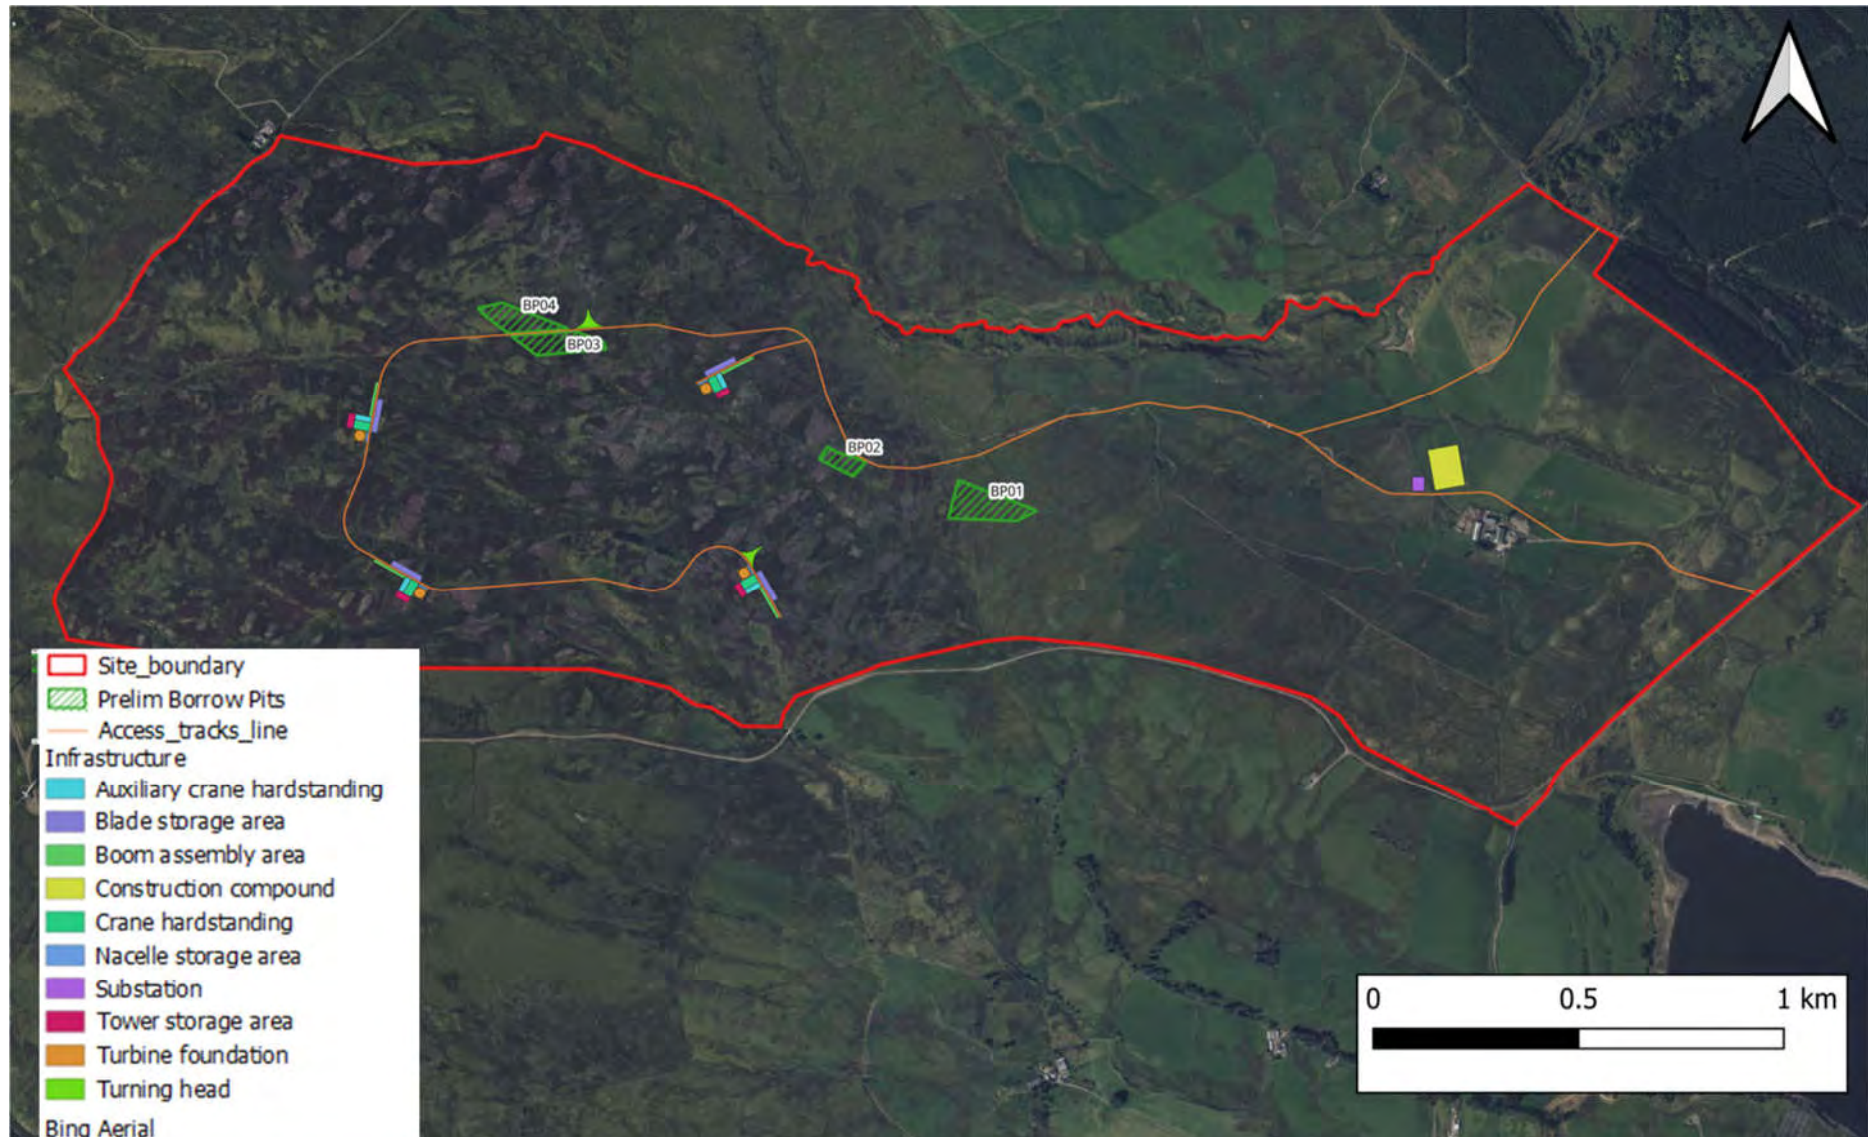
Figure 3-1 Preliminary Borrow Pit Location Areas

Four potential areas have been identified as locations for borrow pits (BP01-BP04). The location of each borrow pit area is identified within Figure 3-1. Each area was selected based on the pre-determined criteria provided by Atmos Consulting Ltd, outlined in Section 3.2.

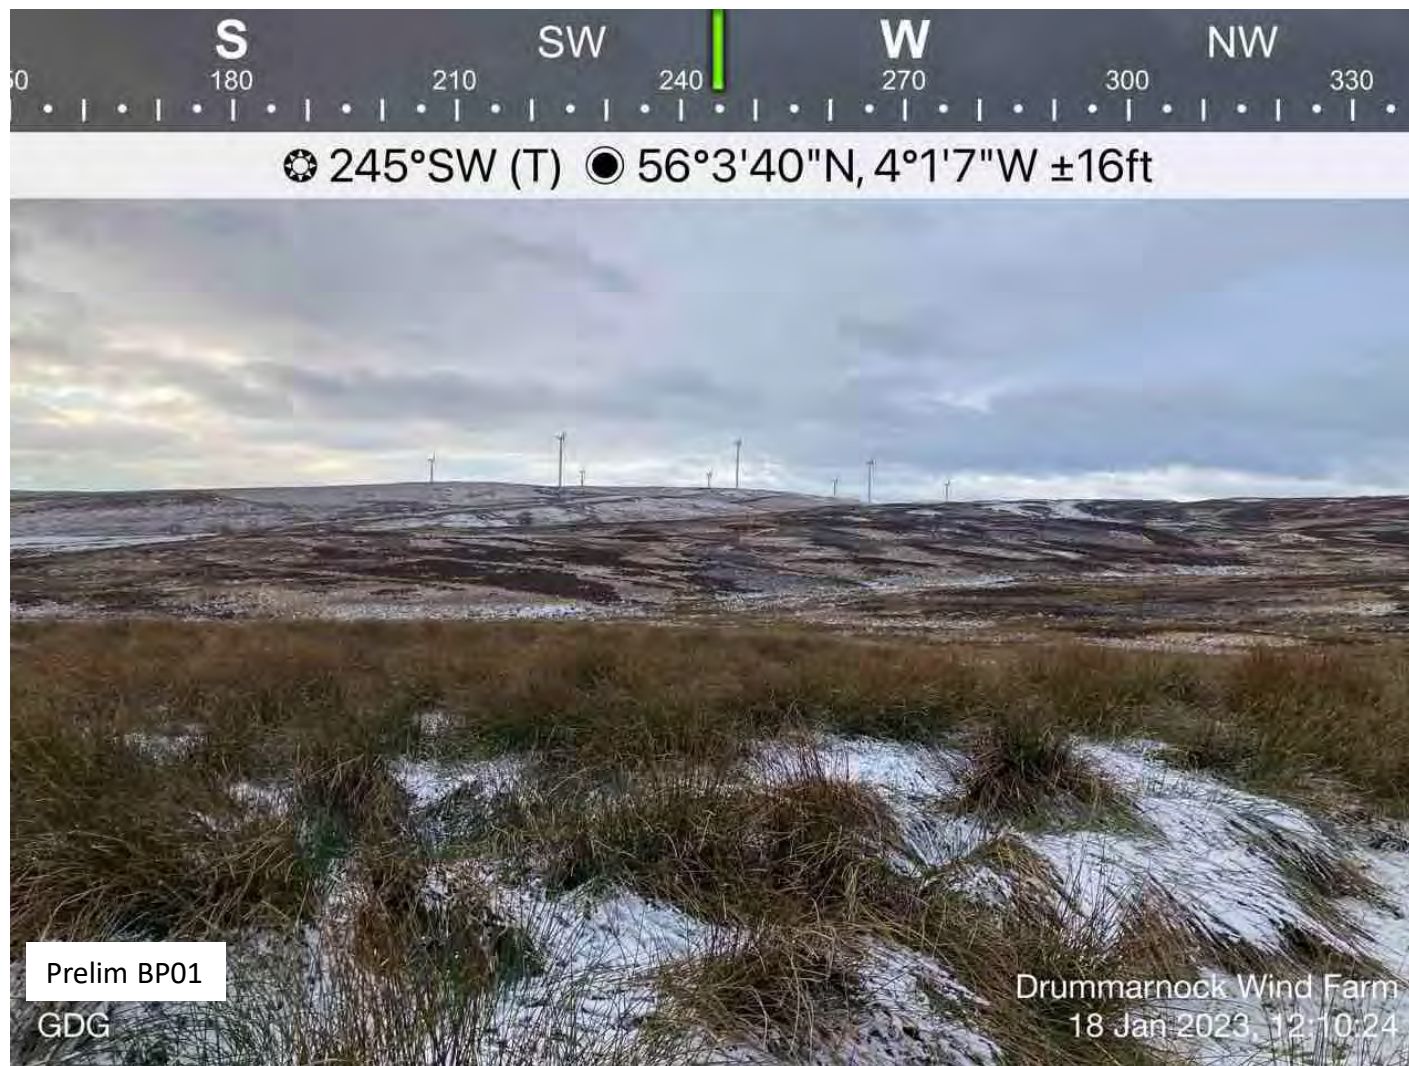
Preliminary Borrow Pit ID	Photograph Reference Number (Appendix A)	Location Description
BP01	1 – 4	The area of preliminary BP01 was observed to dip gently to the southwest and level out to the west where the low-lying area became a saturated bog. In this preliminary location there were no rock outcrops observed. Vegetation was dense was mostly long grasses and sparse pockets of heather.
BP02	5 – 11	The area of preliminary BP02 was observed to dip gently towards the southeast. Locally there were some boulders and exposed bits of bedrock, they were heavily weathered and covered in lichen-like vegetation. No large rock outcrops were observed.
BP03	12 – 18	The area within BP03 was observed to be sloping steeply to the east. In the west of the area there was a localised steeper slope with rock exposed, although was hard to identify as it was heavily weathered (photograph 15). There were a few locations where rock was outcropping from the vegetation, this is likely a result of shallow peat depths.

Photograph 1: View from the eastern boundary across Prelim BP01, looking downslope.

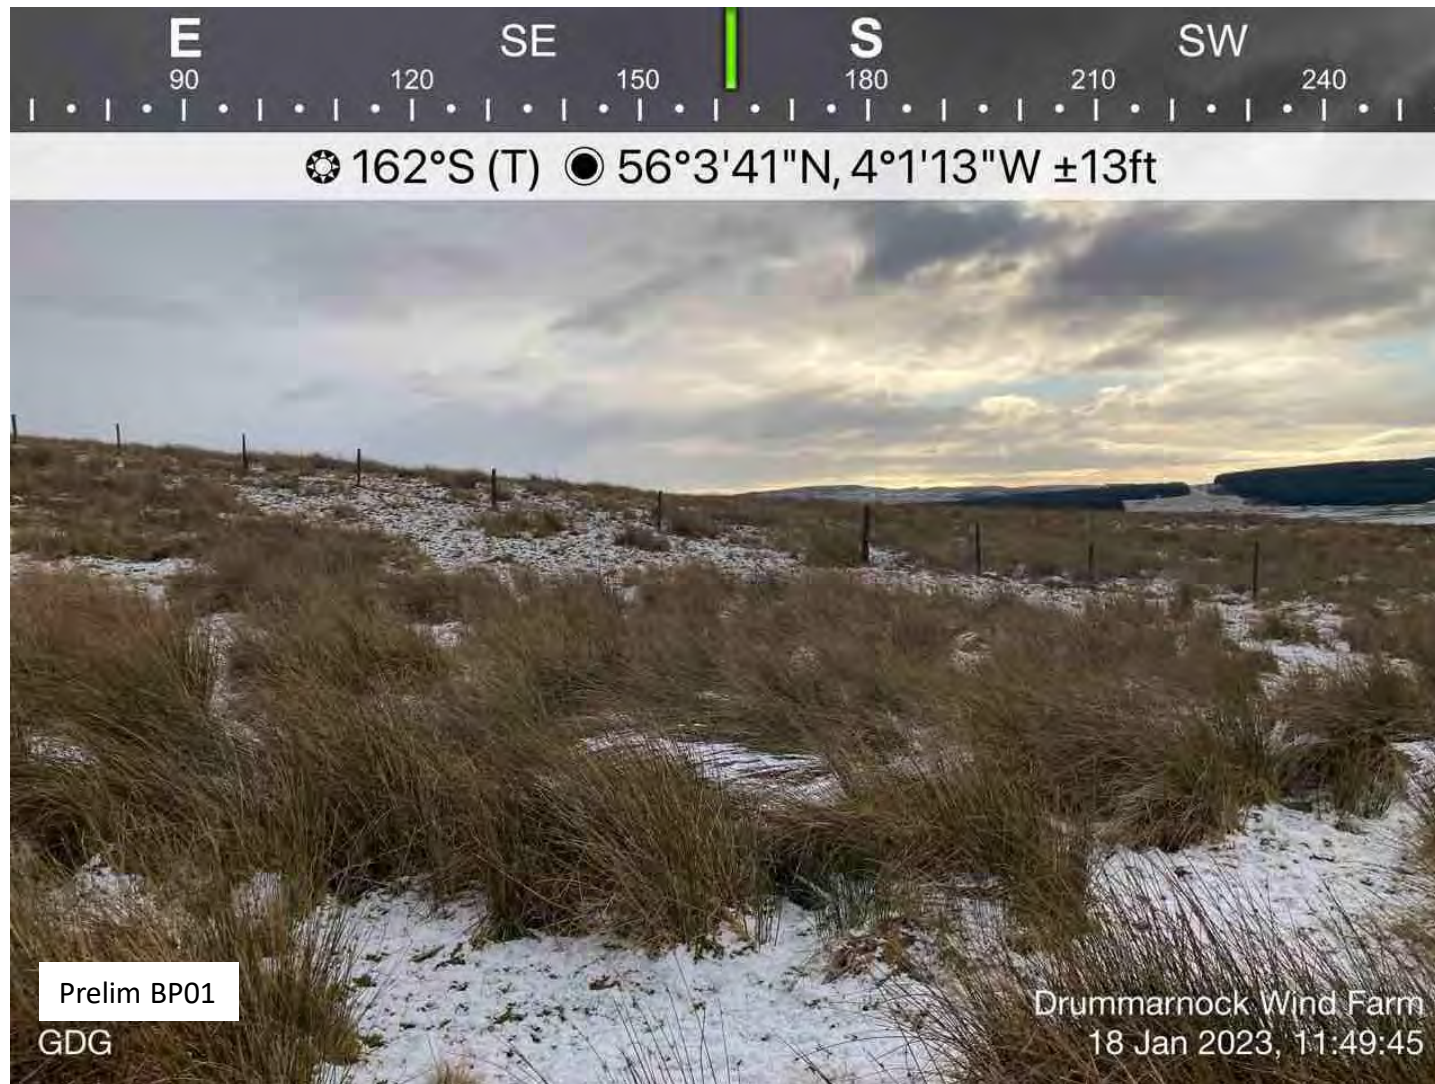
Photograph 2: View south from the northern boundary across the Prelim BP01.

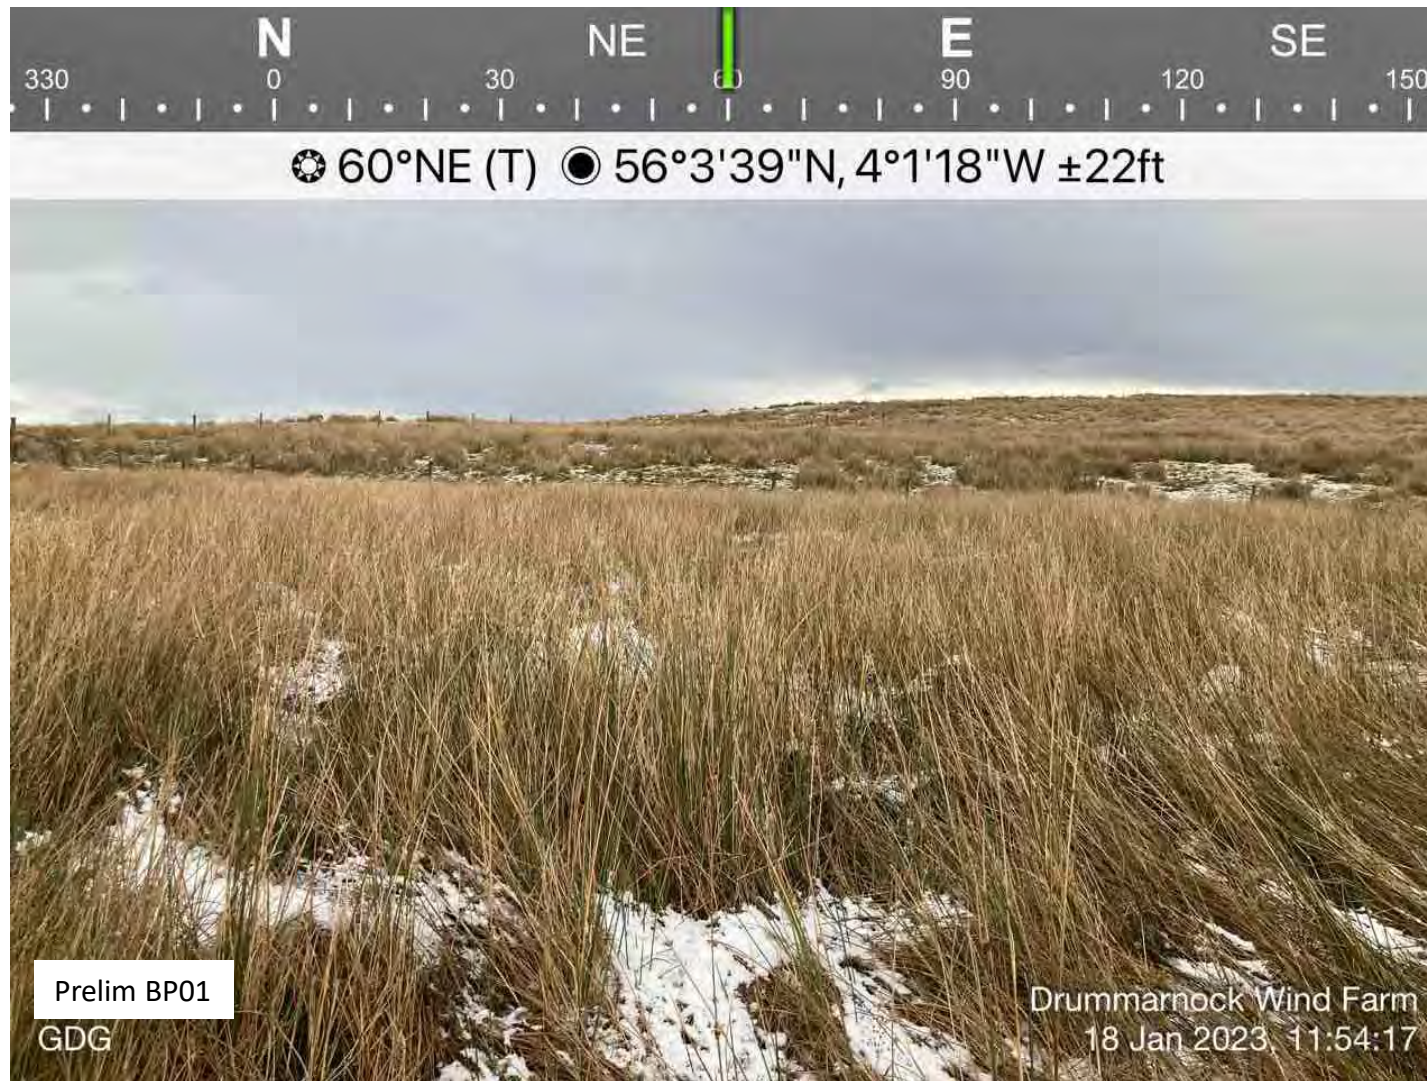
Photograph 3: View from the southwestern corner of Prelim BP01. Looking up-slope from the flat-lying marsh area.

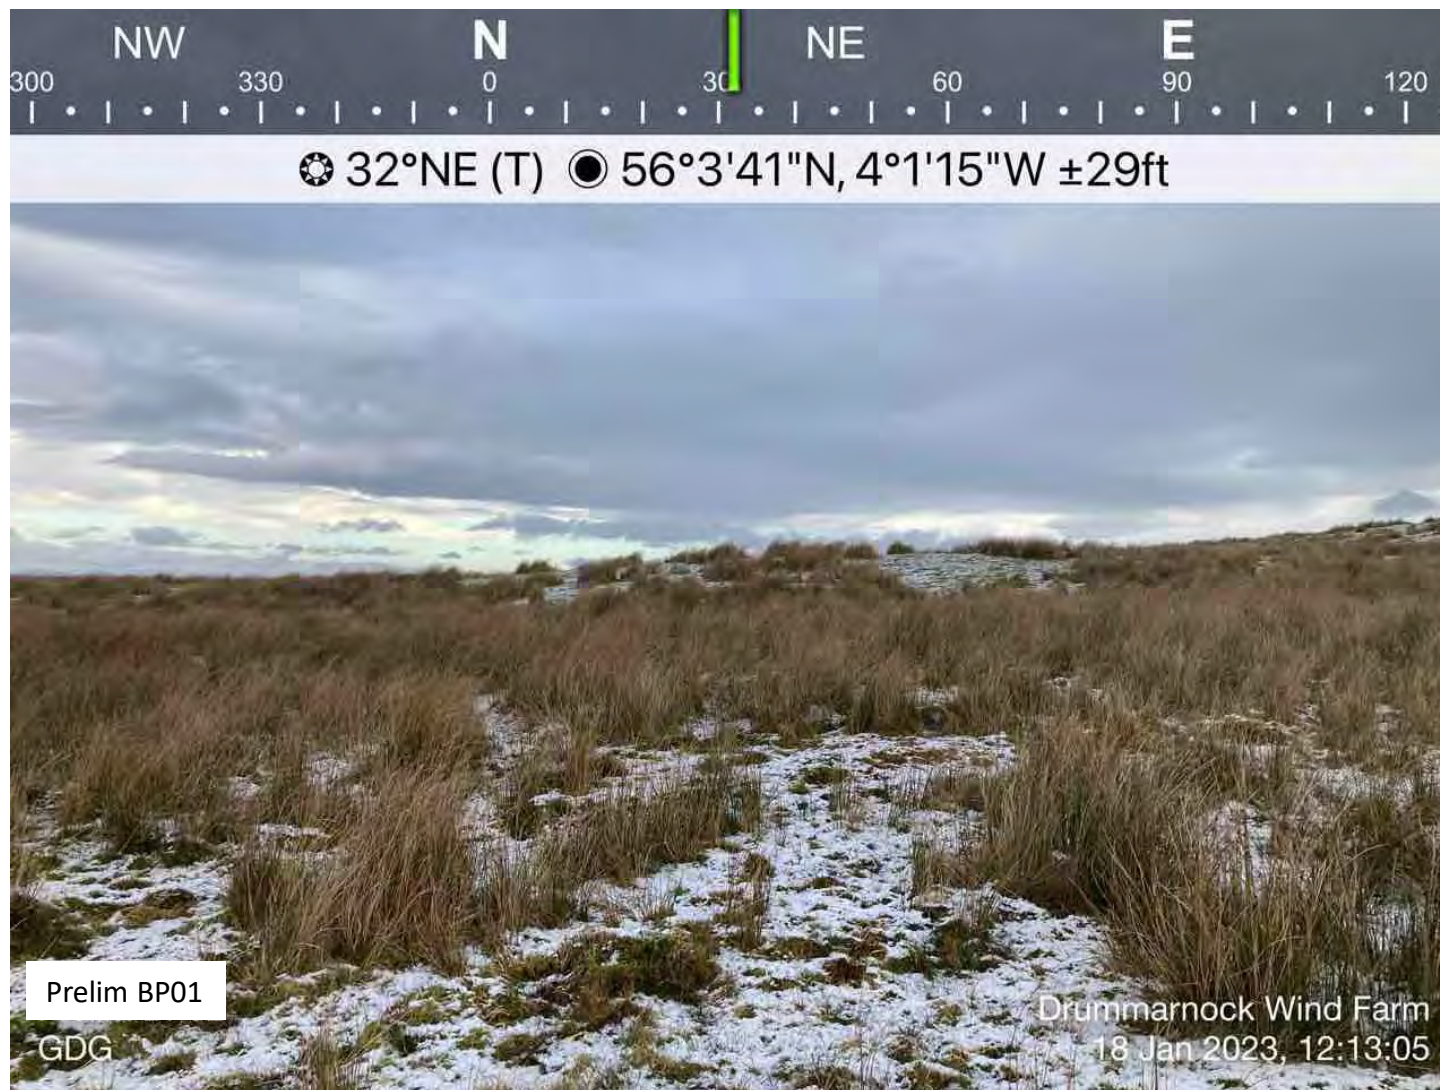
Photograph 4: View looking northeast up slope from the southern boundary of Prelim BP01.

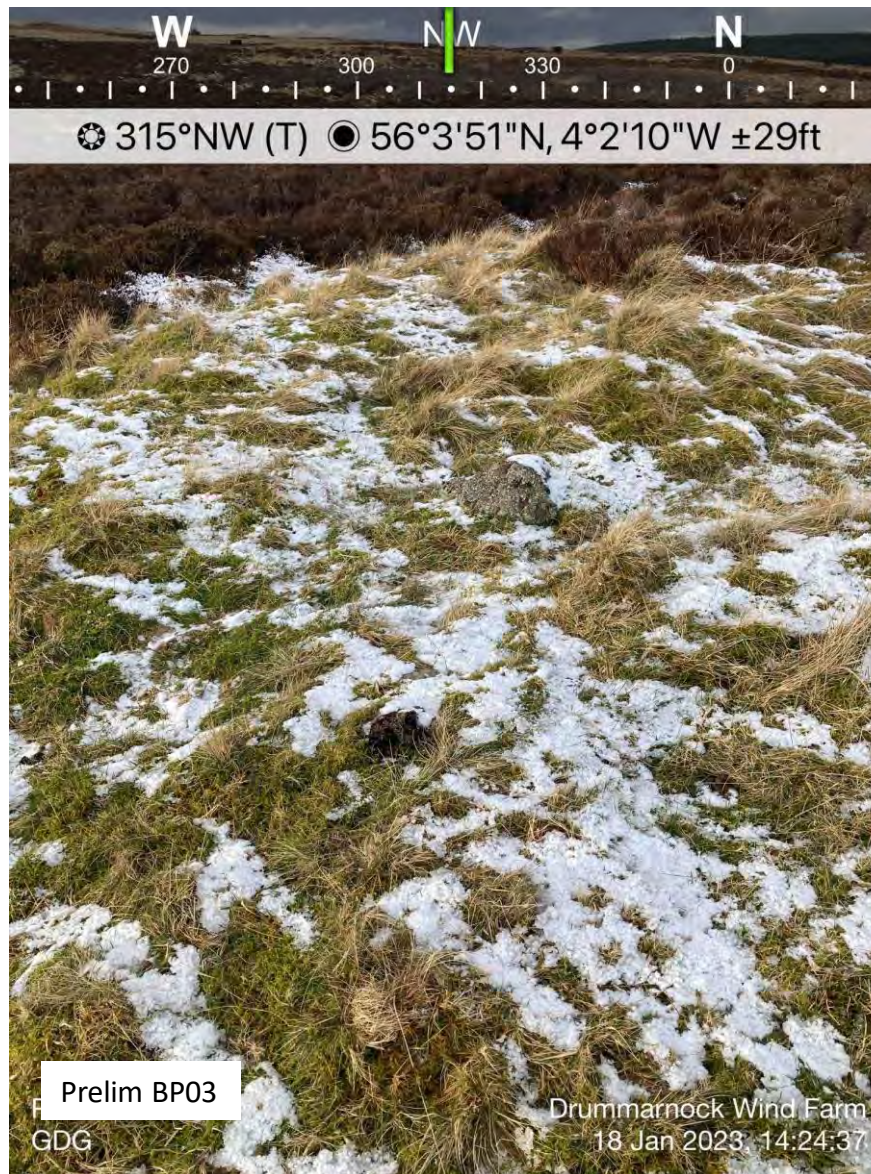
Where rock was exposed, it was difficult to identify the lithology as across the site it was highly weathered or covered in lichen-like vegetation. Most frequently when exposed rock was observed it coincided with appeared shallower peat depths.

Photograph 14: Rock outcrop exposed within Prelim BP03

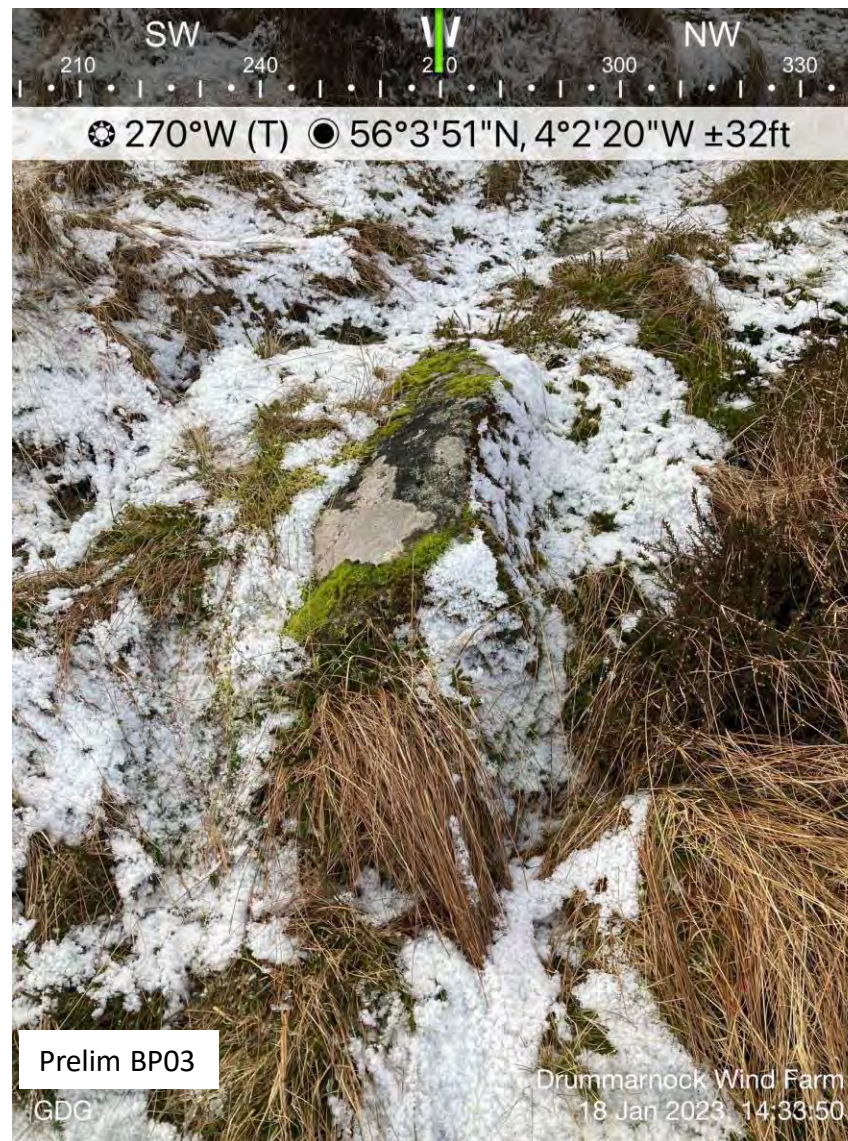
Photograph 15: Weathered rock exposed in Prelim BP03.

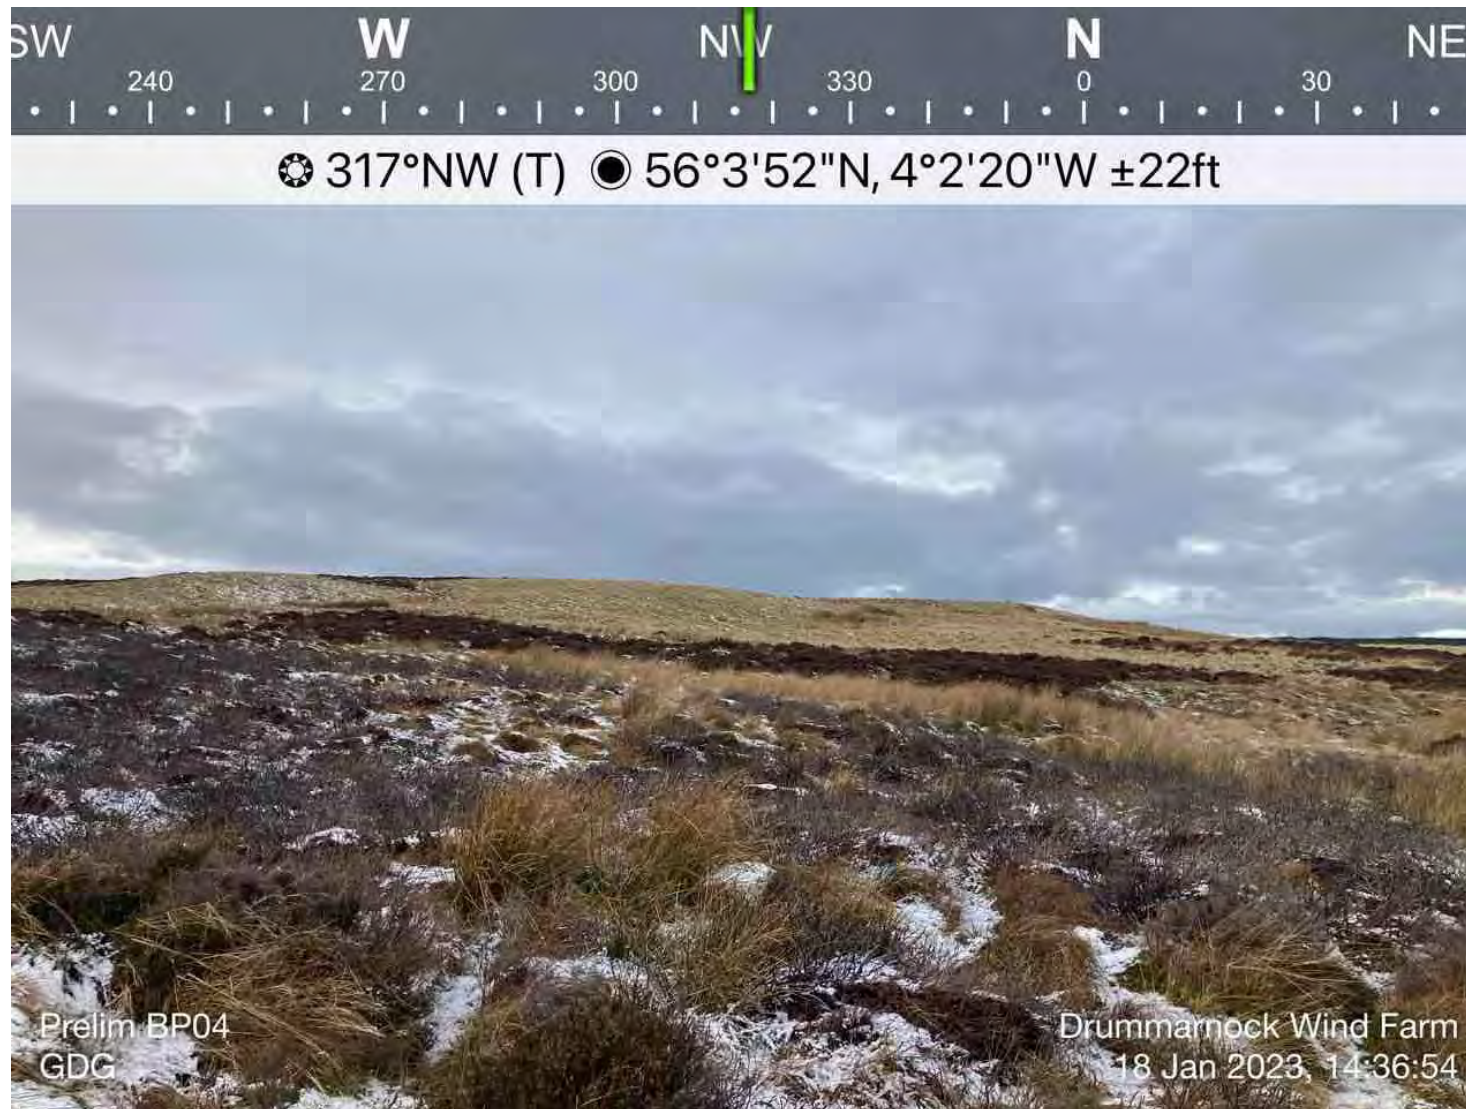
BP04	18 – 22	The area within preliminary BP04 was observed to steeply dip south-eastwards with localised areas of undulation and steeper slopes. There were only localised areas of rock protruding where the peat appeared shallow.

Photograph 19: View northwest from the south eastern corner of Prelim BP04, area overview.

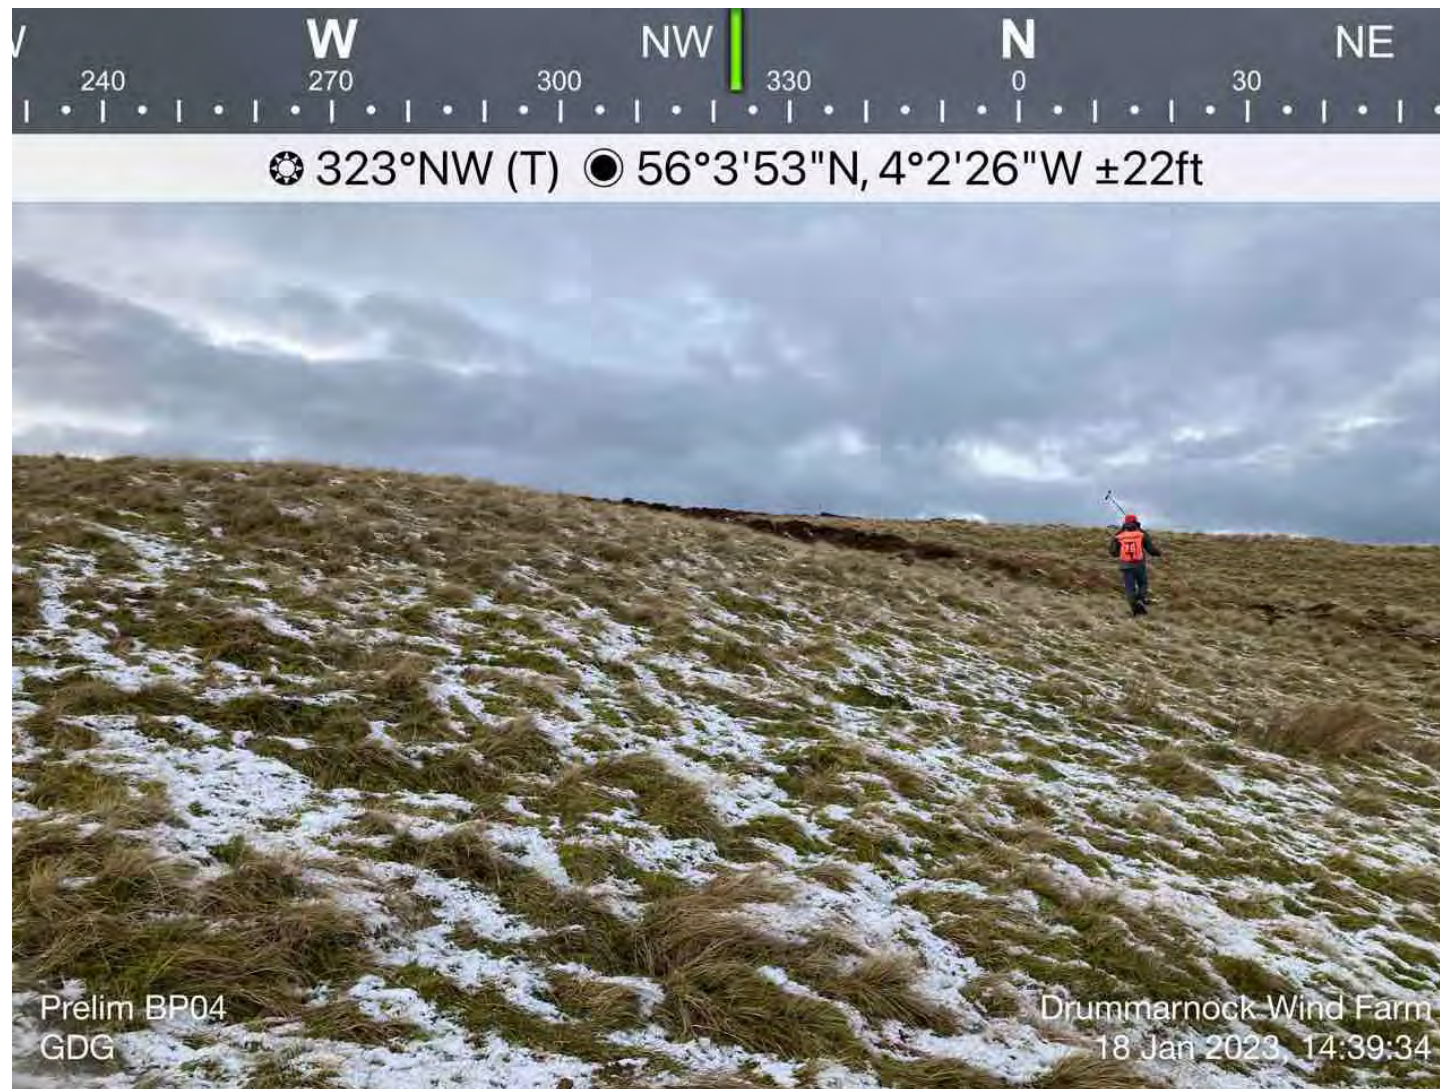
Photograph 20: View from southwestern corner of Prelim BP04 northwest along the western boundary.

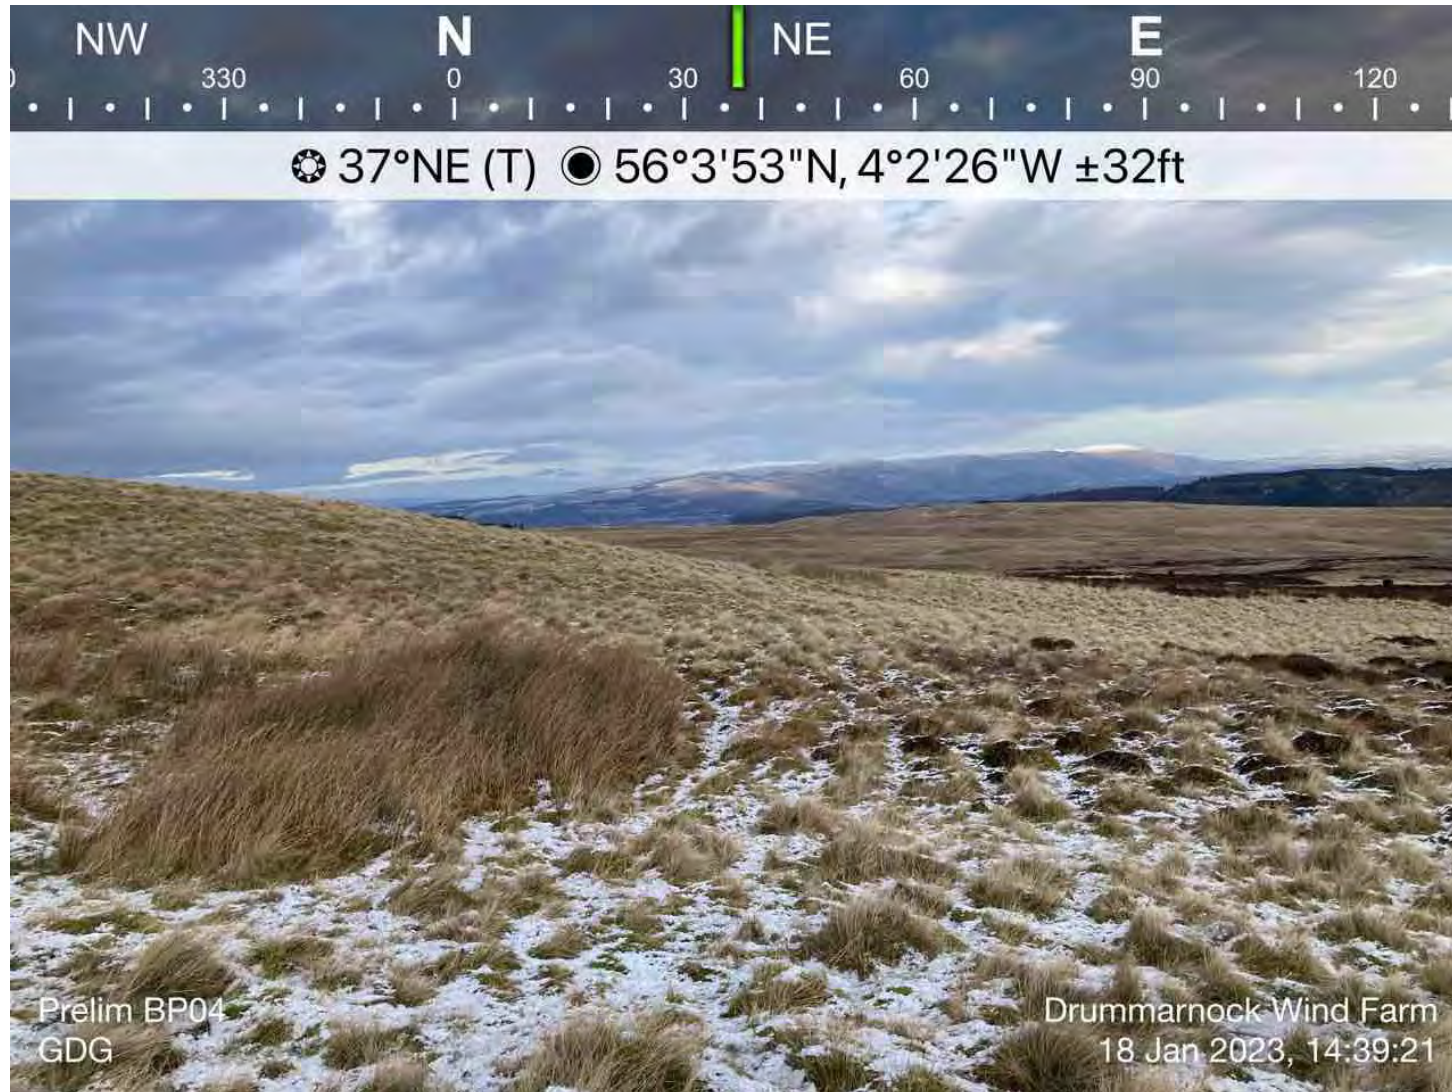
Photograph 21: View from the southwestern corner of Prelim BP04 northeast.

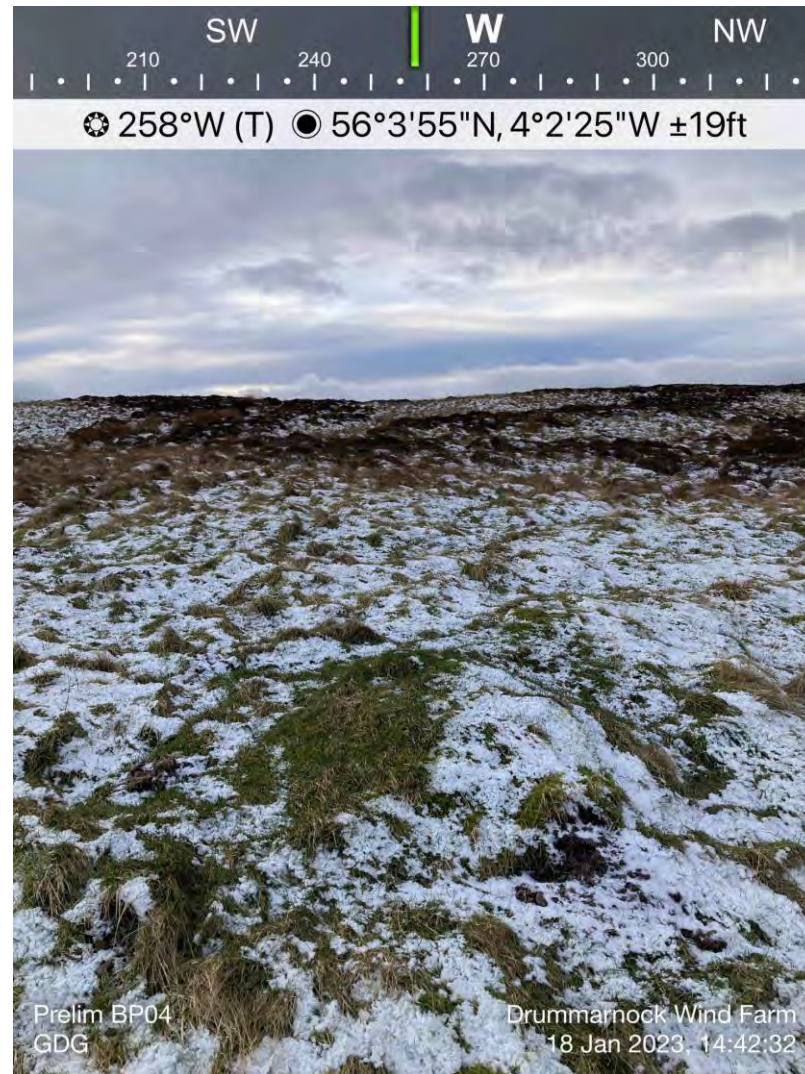
Photograph 22: View west upslope of Prelim BP04.
