Drummarnock Wind Farm

Technical Appendix 6-3: Bats

Drummarnock Wind Farm Limited

July 2024

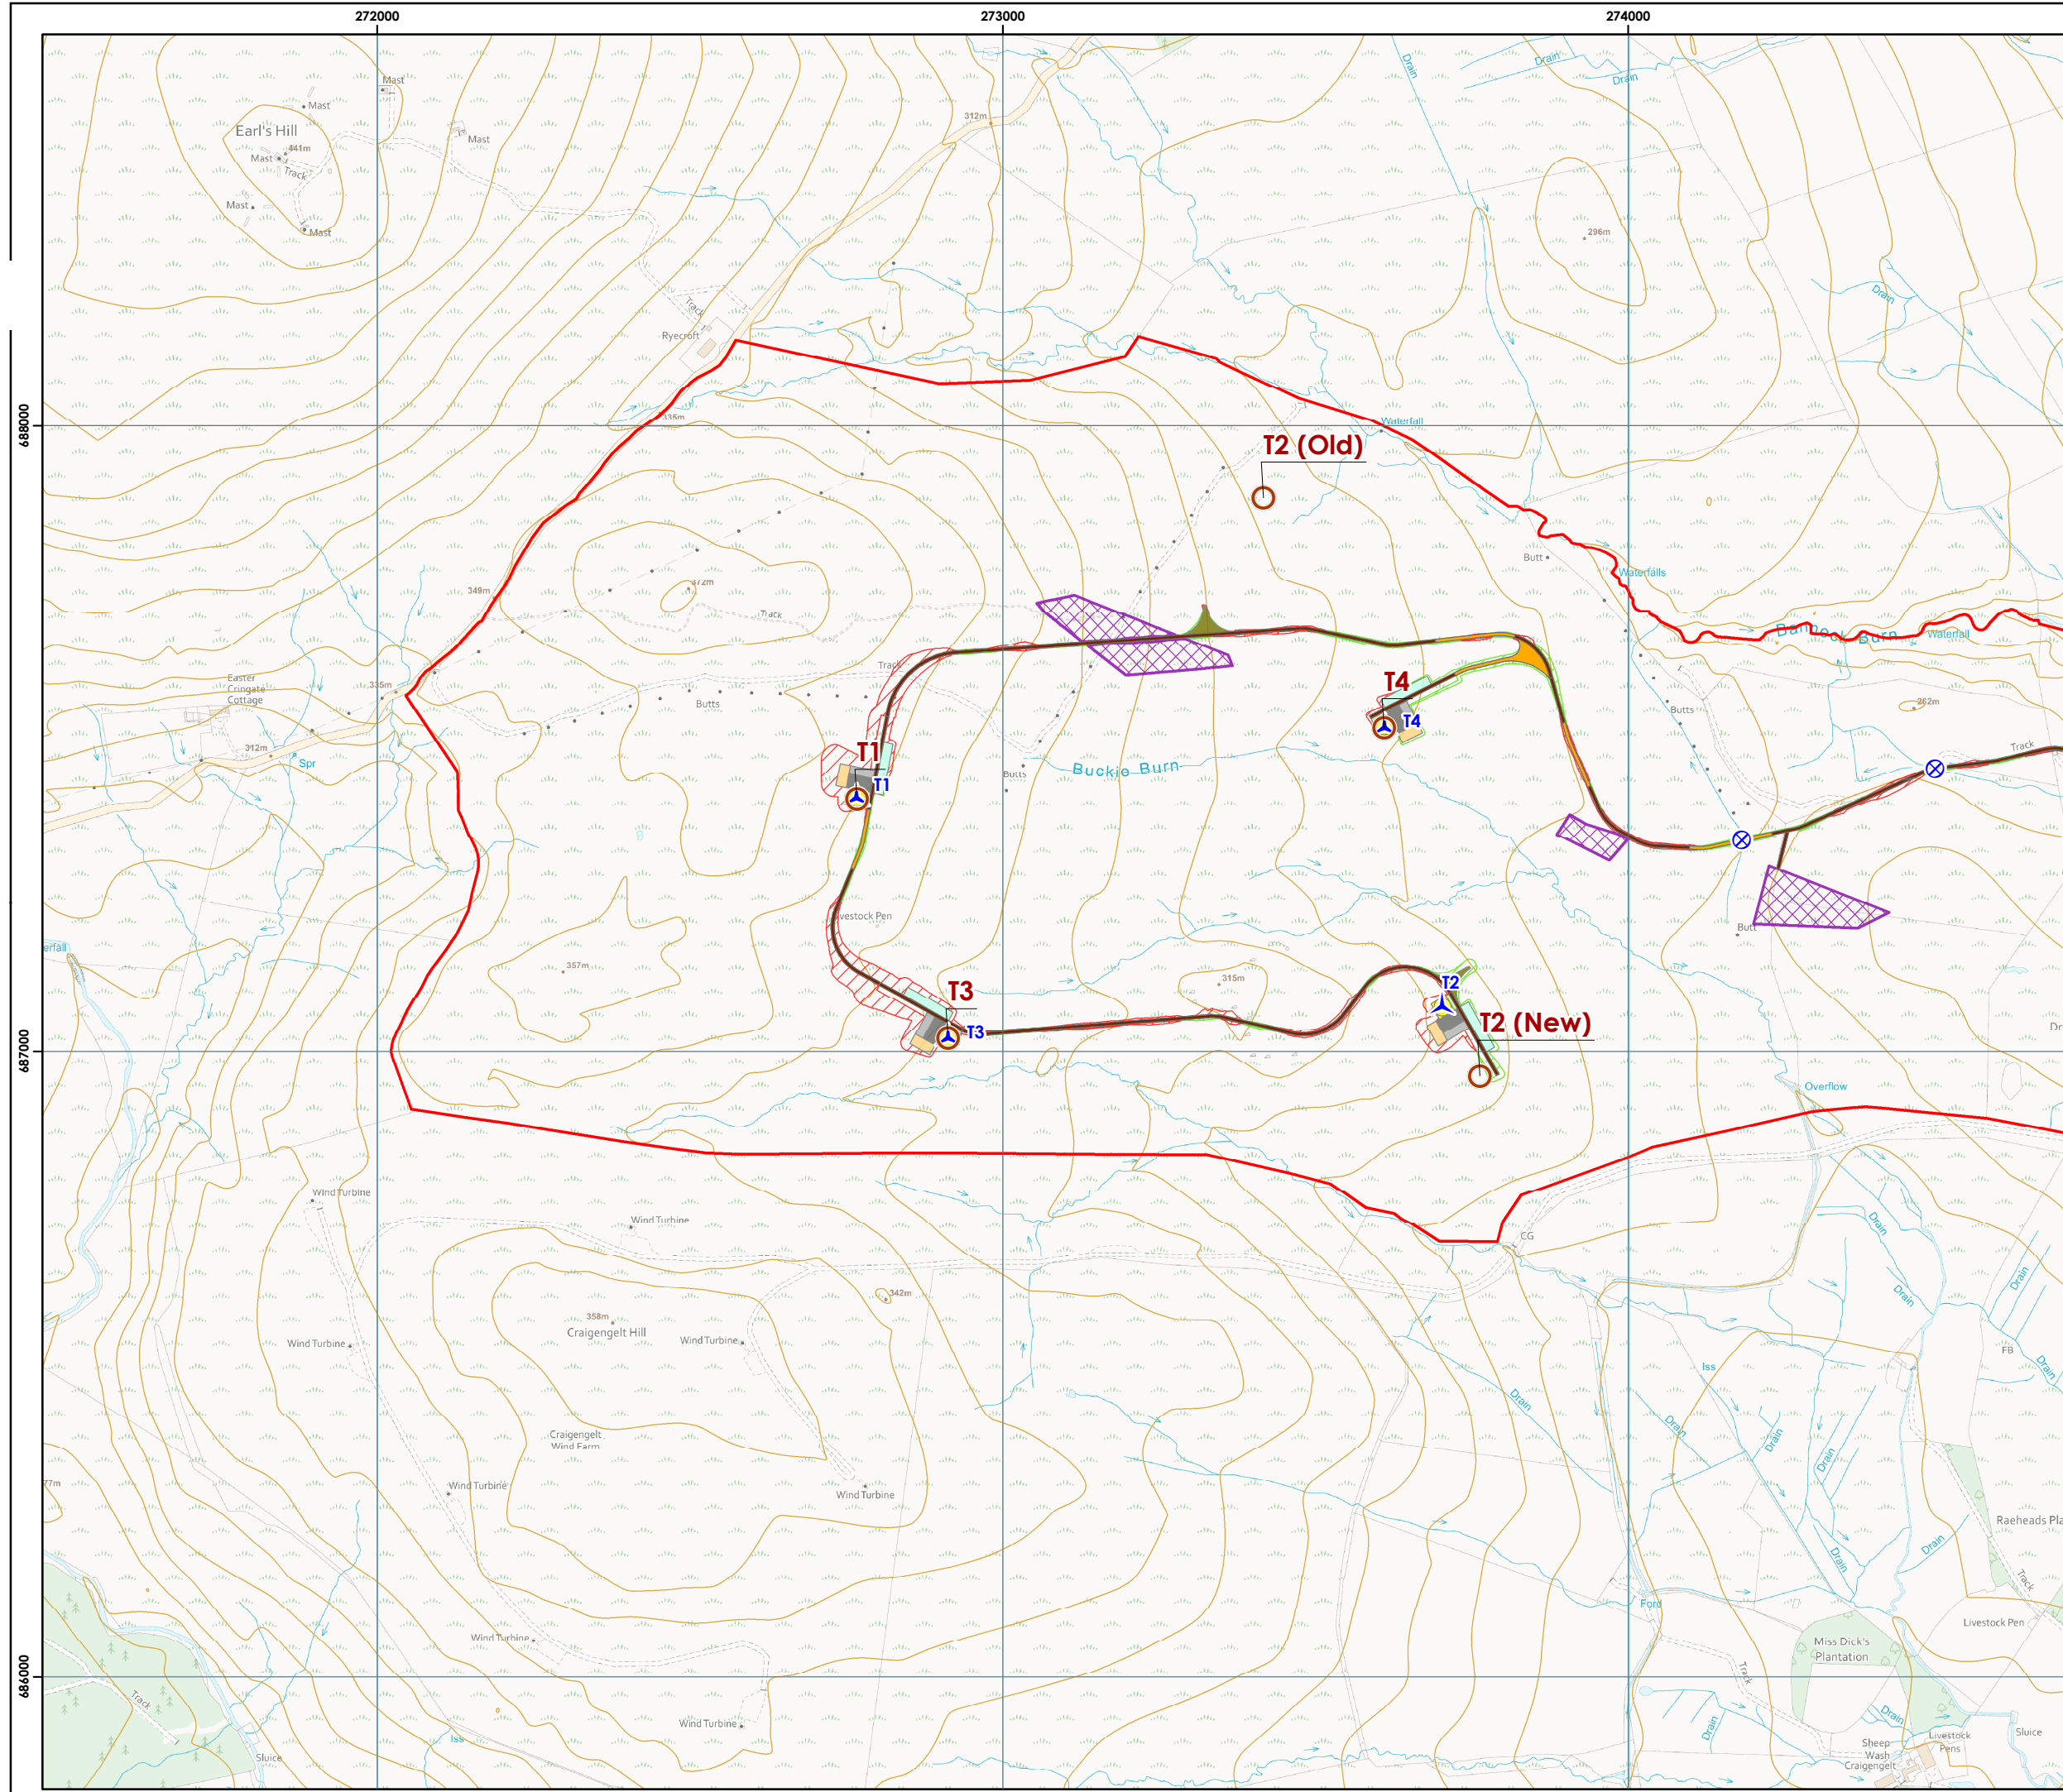
The four locations correspond to the Proposed Development Site design layout that was in place during the start of the survey period. The layout of the Proposed Development Site has evolved through the design process; therefore, the third survey period involved the deployment of five detectors to accommodate the change of location for T2, see Figure 6-3-3.
