# Drummarnock Wind Farm

Technical Appendix 8-1: Watercourse Crossing  
Assessment

Drummarnock Wind Farm Limited

July 2024

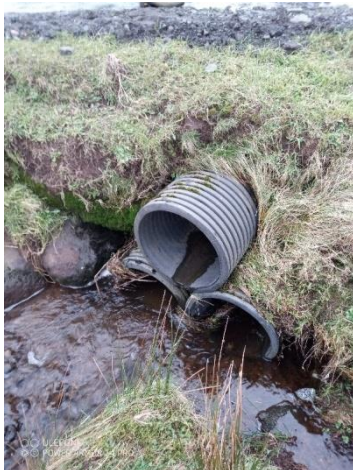
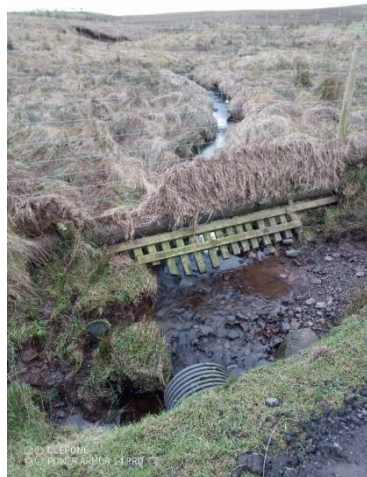
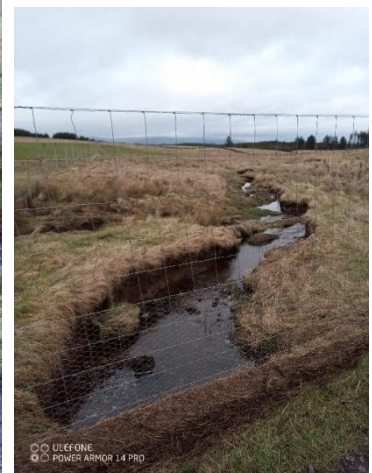
<b>ID</b>	WC1
<b>NGR</b>	NS 75914 87135
<b>Elevation</b>	c 202m AOD
<b>Infrastructure</b>	Existing crossing over Buckie Burn tributary, with 3 x 0.4m diameter. Plastic culverts. The bottom two culverts are 50 % submerged. One culvert has a 0.5m drop fall which has formed a pool. There is a 0.4m overburden padded with rocks. The existing track is 5m across.
<b>Current Setting</b>	Located in a 15m wide valley with incised channel 1m width x 0.5m deep. There are zig zag meanders upstream with till and possibly alluvium in banks and some minor braiding. Water is 0.3m deep. There is a downstream incised channel, whose dimensions are 1.5m x 0.5m deep.. The upstream channel is extensively scoured indicating significant flow. There is a roadside ditch entering upstream from East and West. Downstream is fenced off for forestry. The watercourse crossing is joined downstream by a tributary from Muirpark Farm. This crossing has by a strong margin, the largest flow of all watercourse crossings.

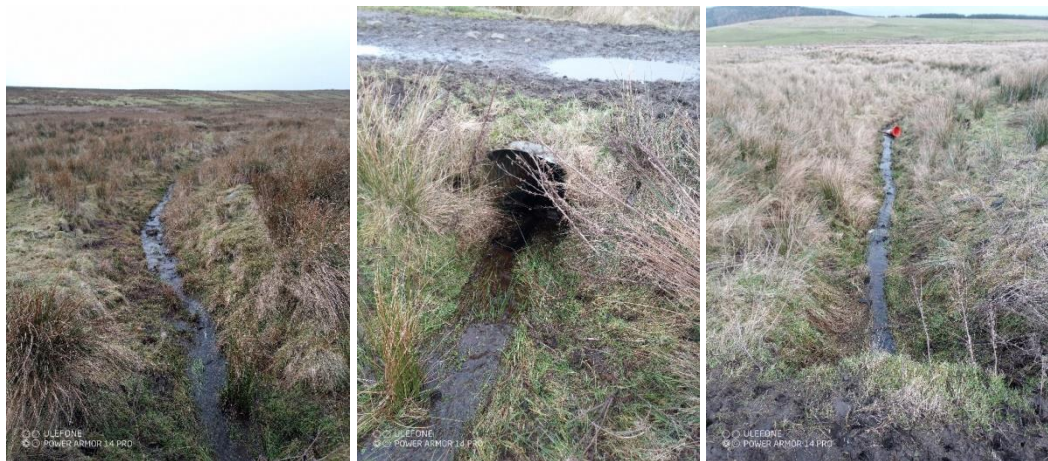
<b>ID</b>	WC2
<b>NGR</b>	NS 75191 87303
<b>Elevation</b>	c225 mAOD
<b>Infrastructure</b>	The crossing is of a minor unnamed watercourse tributary of the Buckie Burn, via an existing culvert on a farm track. The track is 4.5 m across with <0.2m of overburden. The culvert is 0.8m diameter, made of corrugated iron with a small lip downstream. There is no lip upstream and culvert is not sunken.
<b>Description</b>	<p>The upstream valley is 5m x 1.2m deep. The watercourse channel is 0.8m x 0.05m deep. The downstream valley is slightly steeper, at 4m x 1.5m deep with watercourse channel 0.8m x 0.1m deep. There are slight meanders upstream with gentle bend downstream.</p> <p>The substrate is grit and cobbles. Banks are composed of fine-grained silt. Vegetation present in stream. The stream is flowing North at perhaps 0.2L/s with evidence of stronger flow. Habitat is MG10.</p>

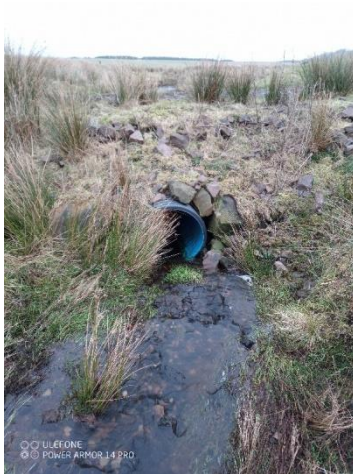
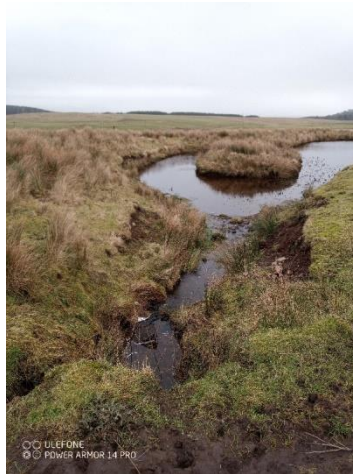
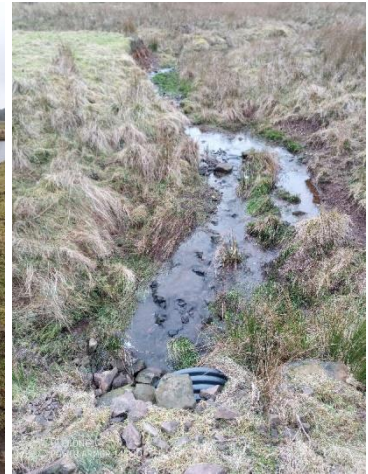
<b>ID</b>	WC3
<b>NGR</b>	NS 75138 87347
<b>Elevation</b>	c 228 mAOD
<b>Infrastructure</b>	This is an existing culvert crossing of a minor watercourse tributary of the Buckie Burn. The track is 4m wide with around 0.15m of overburden. There are signs of two culverts. There is a corrugated iron culvert downstream. This culvert is deformed with a 0.3m drop fall which has formed a pool. The upstream culvert is plastic, 0.6 m diameter and slightly sunken.
<b>Description</b>	<p>The crossing is located in an 8m wide valley x 1.5m deep. The actual channel is 0.8m x 0.3m wide with water up to 0.2m deep. There is evidence of water rising to fill the channel. There is minor braiding with some vegetation in channel.</p> <p>The banks upstream are alluvium with rust colour and fill. The downstream banks contain alluvium.</p> <p>Downstream opens up into artificially impounded farm pond with PWS within 5metres, The pond is not a registered PWS but it is confirmed that it is for agricultural use.</p>

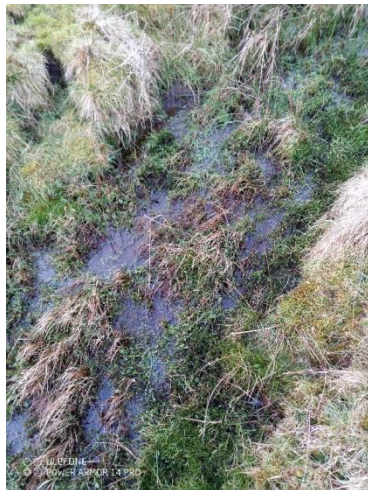
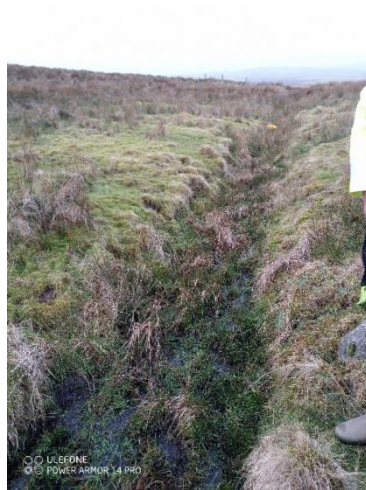
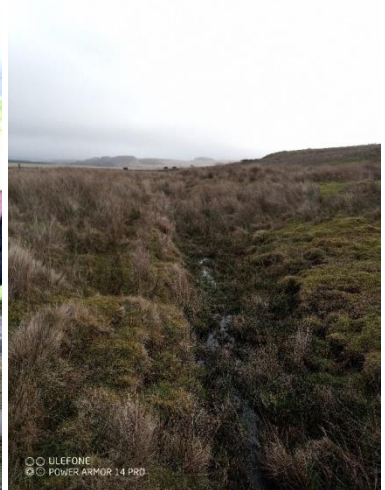
<b>ID</b>	WC4
<b>NGR</b>	NS 74562 87430
<b>Elevation</b>	mAOD
<b>Infrastructure</b>	This will be a new crossing of an unnamed minor watercourse which drains to the Bannock Burn to the north,
<b>Description</b>	The watercourse is effectively just an artificially straight section likely cut for drainage. The watercourse runs across a green track with no evidence of culverts. It is on or close to the catchment divide between Barvie and Bannock Burns. The Drainage Impact Assessment will identify whether it can be filled in and avoid a watercourse crossing here or whether some minor culverting will be needed. It is in a shallow valley 4m across and 0.5m deep. There is a 0.8m channel with depth of 0.05 m. Channel is full of waterlogged vegetation. There is a very low flow eastwards. No evidence of flooding. Habitat is MG10 with 0.4m deep peaty soil on south and west – with silt substrate.

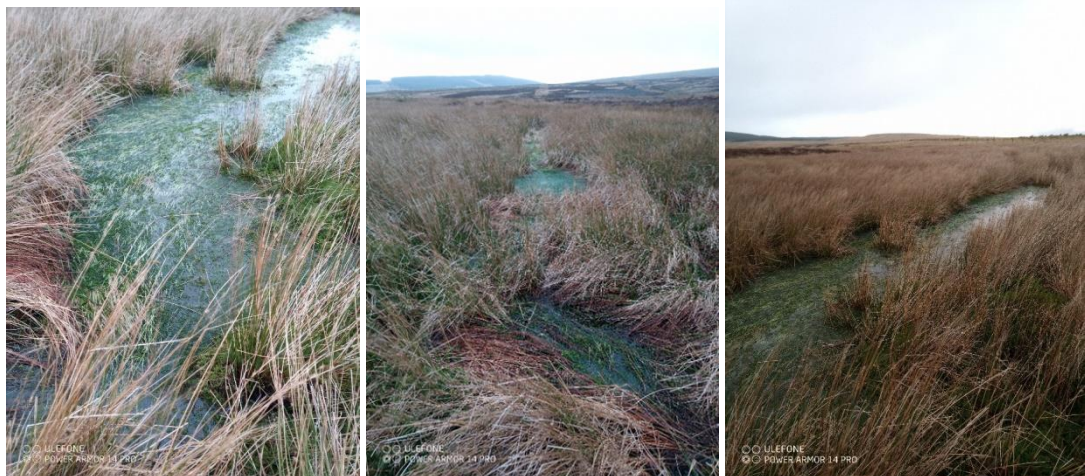
<b>ID</b>	WC5
<b>NGR</b>	NS 74180 87306
<b>Elevation</b>	c 267 m AOD
<b>Infrastructure</b>	This will be a new crossing of an unnamed watercourse, a tributary of the Bannock Burn.
<b>Description</b>	The crossing is in a wide flat bottomed valley 80-100m across. The entire valley is a linear SSW/NNW saddle wetland. The current crossing location is just north of the Bannock Burn / Buckie catchment divide and consists of multiple streams leading to the Bannock Burn. The actual watercourse channel is up to 2m across with water depth of 0.5 m. It is fed by run off from surrounding small hills to W and E and groundwater baseflow and rainfall. It contains an elongated pool with abundant sphagnum vegetation along its length. The valley channel is mostly straight but does meander slightly. The valley bottom is peaty and waterlogged. In terms of plant communities, the crossing comes off MG10a from the east and goes into M19 blanket bog for 100m west then over a H9 hillock northwest. The crossing itself is located at the boundary of M20a to the north and M6d to the south. There is also surrounding M6 flush. The substrate is deep fully saturated peat. There is no discernable flow.
