Drummarnock Wind Farm

Technical Appendix 8-2: Peat Landslide Hazard
and Risk Assessment

Drummarnock Wind Farm Limited

July 2024

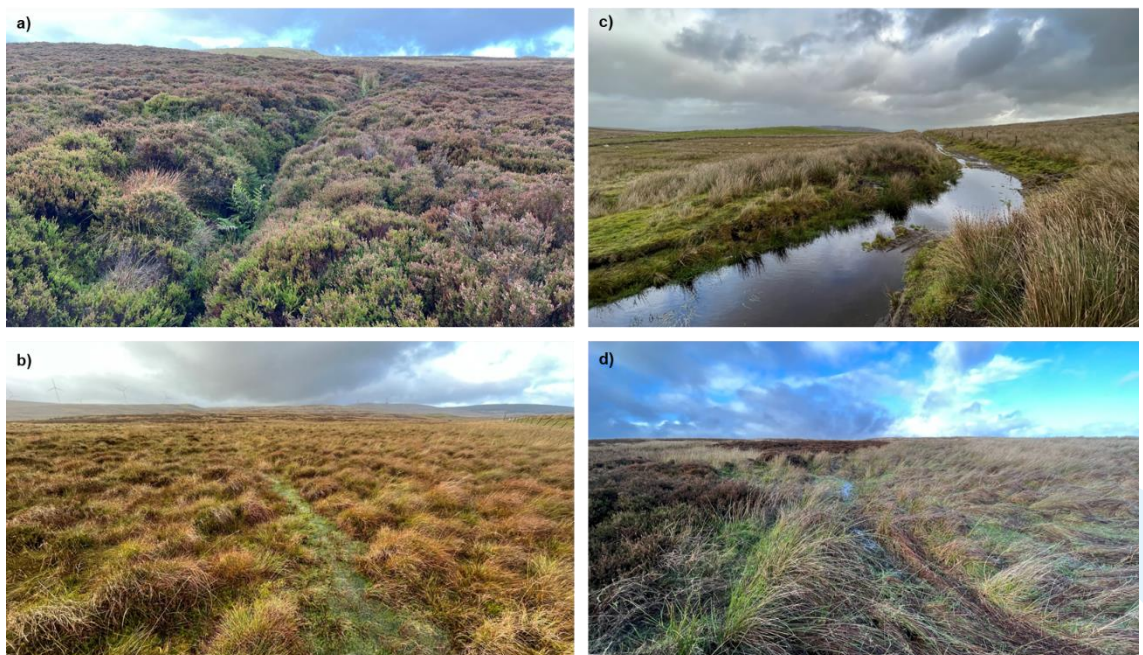
Plate 8-2-5: a) active moor drain in west, b) ineffective moor drain, c) unnamed watercourse in east of Site, d) flushed ground with flattened grasses

There are two primary unnamed minor watercourses draining from west-to-east within the Proposed Development Site itself, each with a number of minor confluences (e.g. Plate 8-2-5c). These converge in the lower slopes in the eastern half of the site into an area of widespread artificial drainage to the north of Craigengelt and south of the proposed main access track. These drains then feed into Loch Coulter Reservoir.

In the undulating hills in the west of the site, there are a number of flush zones that ultimately become minor watercourses. These are generally rush and grass rich and appear as distinct linear pathways among the wider heather moorland. Typical drainage features are shown on Plates 8-2-5a to d.

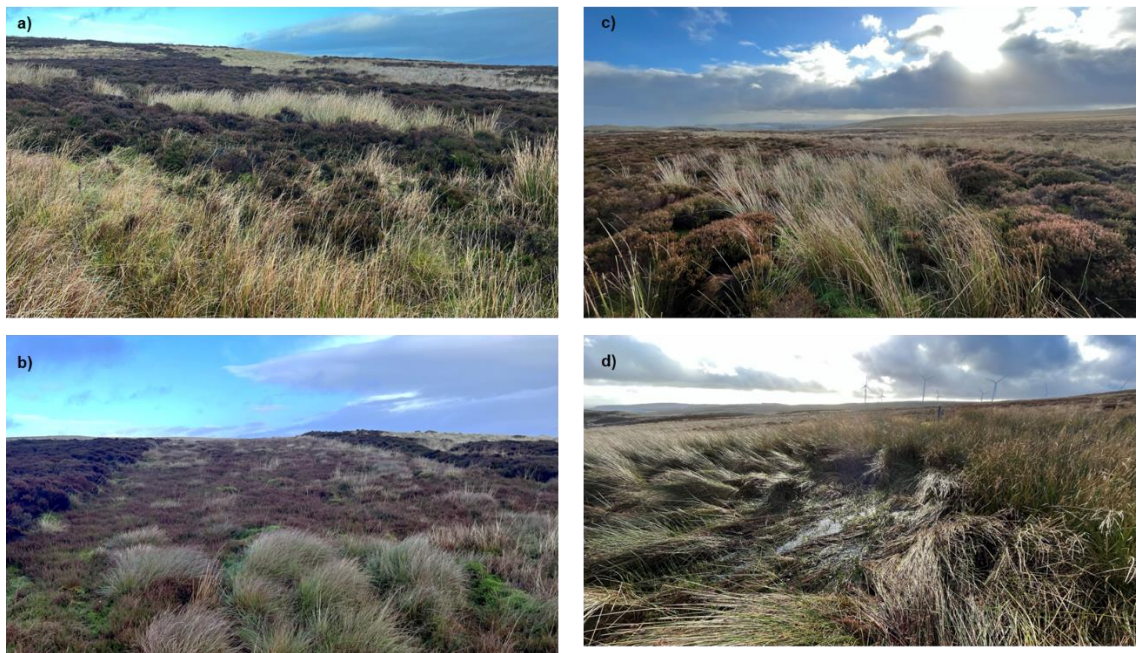
Plate 8-2-6: a) typical open rolling moorland in west of Site, b) burned ground, c) typical planar moorland in west of Site, d) diffuse surface water pathway in centre of site

Large areas of the undulating peat covered hills have been burnt (Plate 8-2-6), and multiple phases of burning are visible on satellite imagery in Google Earth™.
