TECHNICAL APPENDIX 11.3: HERITAGE WALKOVER SURVEY REPORTS

Balmeanach Wind Farm
Prepared for: **Balmeanach Wind Farm Limited**

SLR Ref: 428.V11223.00001
Version No: Final
July 2023

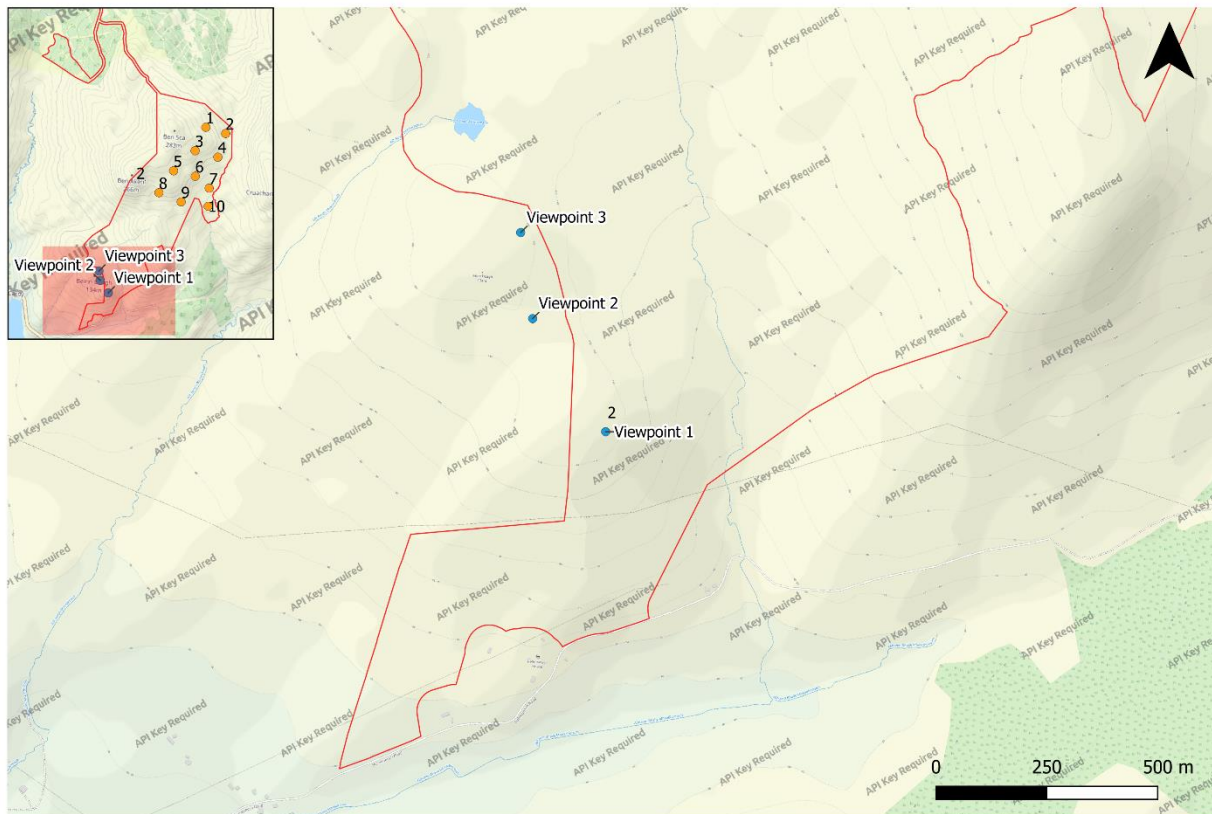
Due to health and safety concerns, only the western side of this area was walked. However, the western rises within the valley provided sufficient views to conclude there were no apparent archaeological features on the eastern slopes, as confirmed with photographs taken from viewpoints 1, 2 and 3. The lower elevation of the valley was also walked, to the west of the major water course running north to south. This confirmed a lack of archaeological features of significant interest.

Plate 12: Viewpoints 1, 2 and 3 within the southern part of the site.

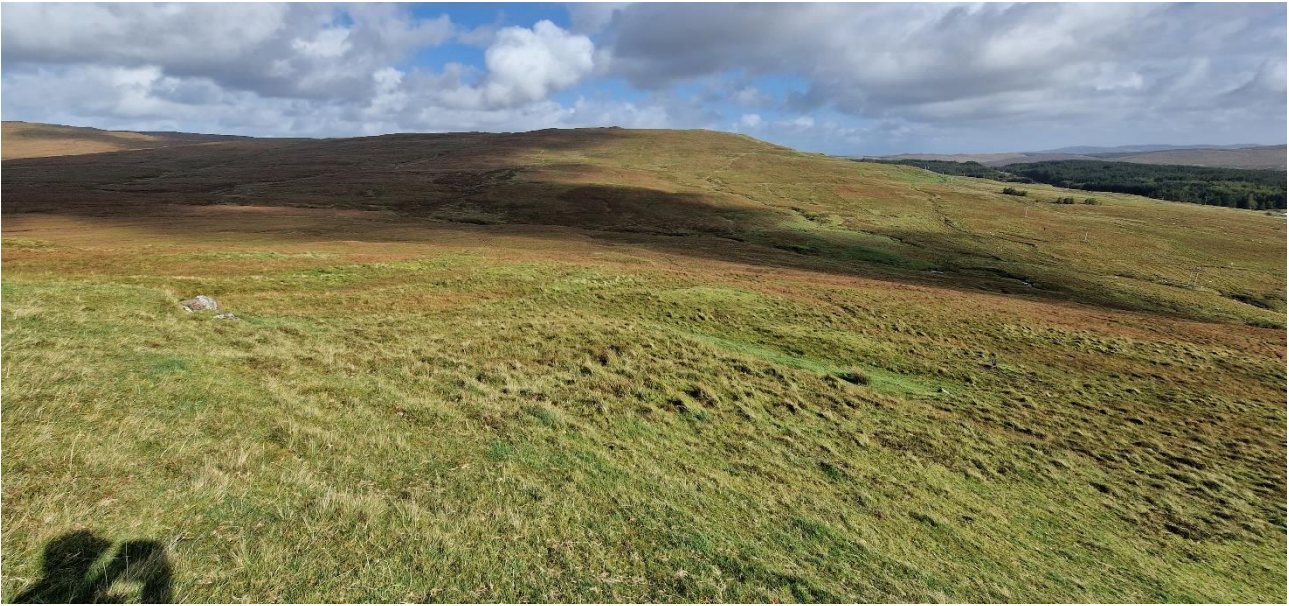
Plate 13: View from Viewpoint 1, looking across the site to the east.

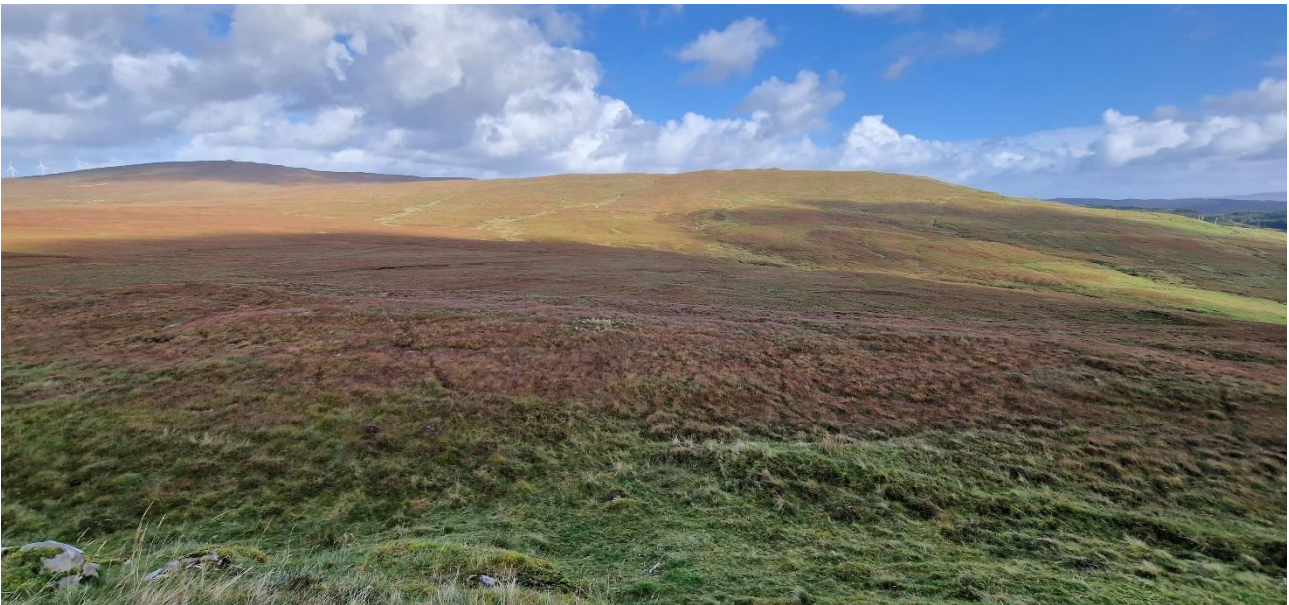
Plate 14: View from Viewpoint 2, looking across the site to the east.

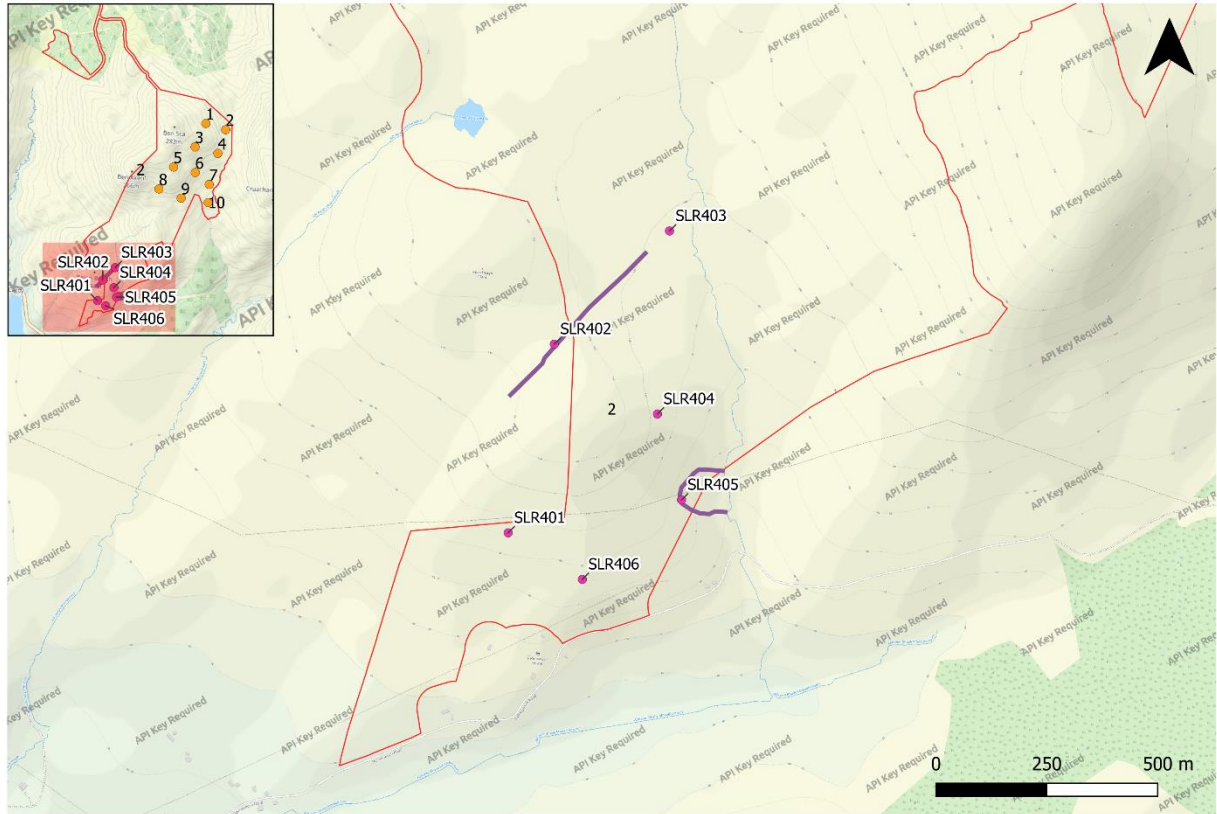
A number of features were identified within the southern part of the scoping site boundary, their location is shown in Plate 15.

Plate 15: Location of Features identified during walkover survey
